AN ASSESSMENT OF THE LAKES AND WATERSHEDS OF ROCKAWAY TOWNSHIP

TOWNSHIP OF ROCKAWAY, MORRIS COUNTY, NEW JERSEY

DECEMBER 2022

PRINCETON HYDRO, LLC
1108 OLD YORK ROAD, SUITE 1
POST OFFICE BOX 720
RINGOES, NJ 08551

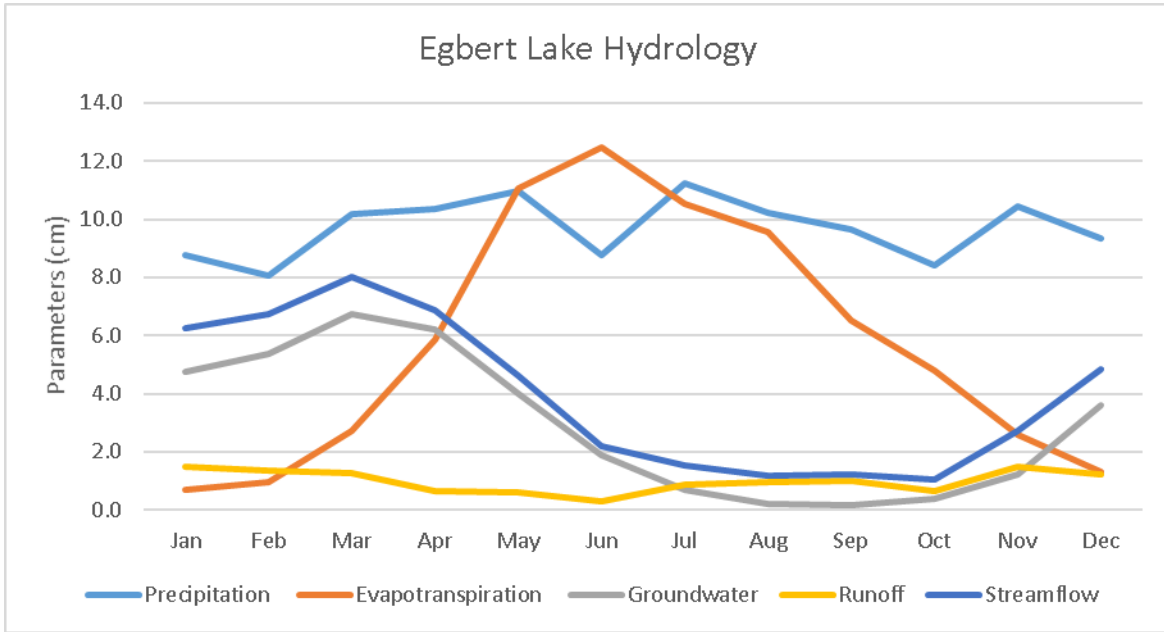
Figure 4. Estimated seasonal changes in hydrology in the Egbert Lake watershed

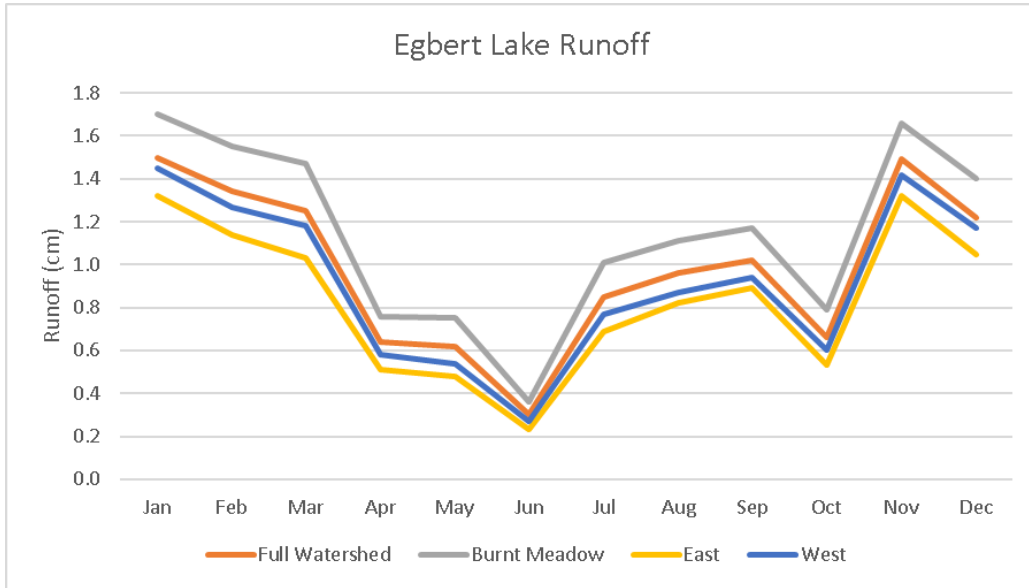
Figure 5. Average monthly runoff within sub-watersheds of the Egbert Lake watershed

Runoff varied at most only approximately 25% between subwatersheds, with Burnt Meadow yielding the highest, likely due to its' relatively high percentage of urbanized landcover when compared to the other two subwatersheds. After factoring in direct precipitation and evaporation to the lake itself, Egbert Lake is estimated to receive approximately 906,300 m³ or 239.4 million gallons of water a year.

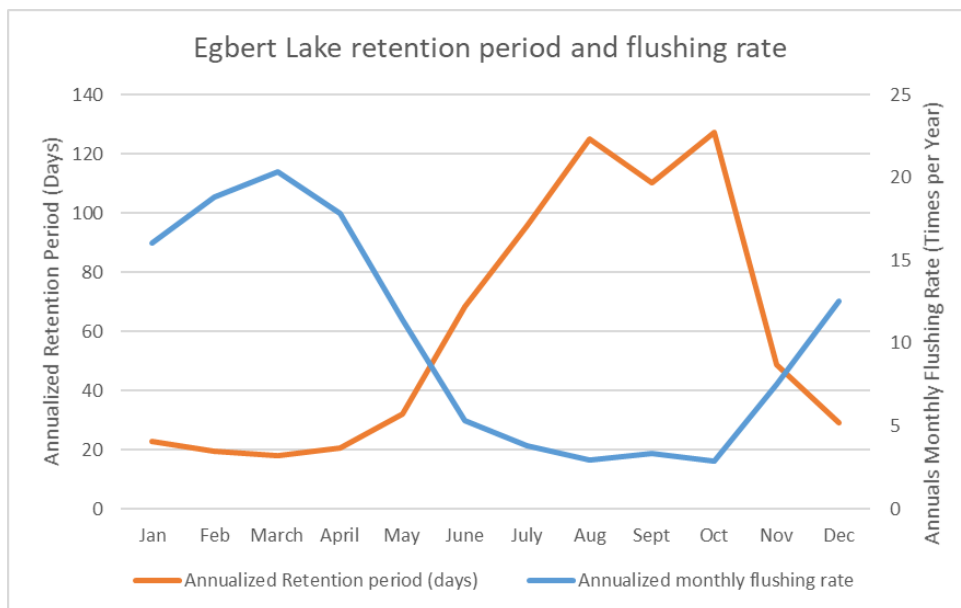
Figure 6. Variations in annualized flushing rates and retention periods over the course of a hypothetical year for Egbert Lake, based on variations in hydraulic loads.

No bathymetry data was found to exist for Egbert Lake; as such, the lake's volume is an estimate based on depths of the sample sites. The Lake is estimated to contain approximately 88,994 m³ or 23.5 million gallons of water. As the lake's volume is much smaller than its estimated hydraulic load, the lake flushes relatively quickly, approximately 10.2 times a year. A unit of water is only estimated to stay in the lake for approximately 36 days; this metric is known as the retention period. The lake's annualized monthly flushing rates are estimated to follow a pattern similar to those of Green Pond, although with the period of reduced flushing occurring moreso towards the end of the summer, while Green Pond's lowest annualized monthly flushing rate occurred in June.

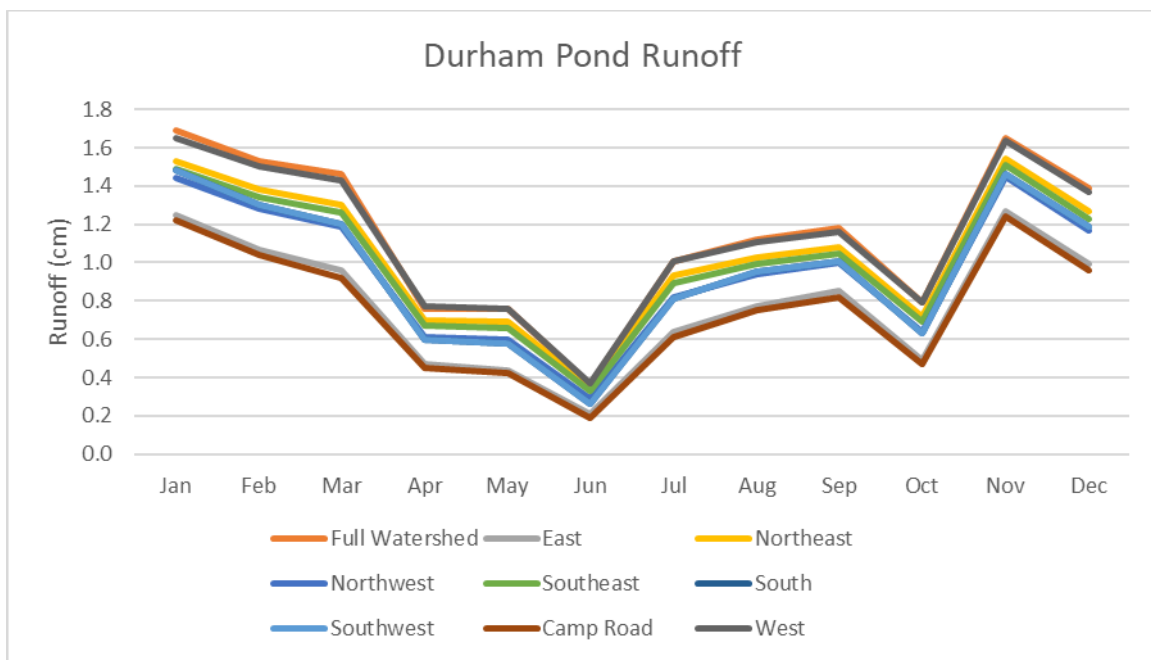
Figure 8. Average monthly runoff within each sub-watershed in the Durham Pond watershed

Runoff into Durham Pond is estimated to be largely similar between the different sub-watersheds, as most of them are largely forested. It should be noted that most of the soils within the watershed are classified as being in the "Slow Infiltration" soil group, suggesting that, during heavy rain events, water begins to runoff from the land relatively quickly. When direct precipitation and evapotranspiration in the waterbody itself is factored in, Durham Pond is estimated to receive an annual hydrologic load of approximately 817,556 m³ or 216 million gallons of water.

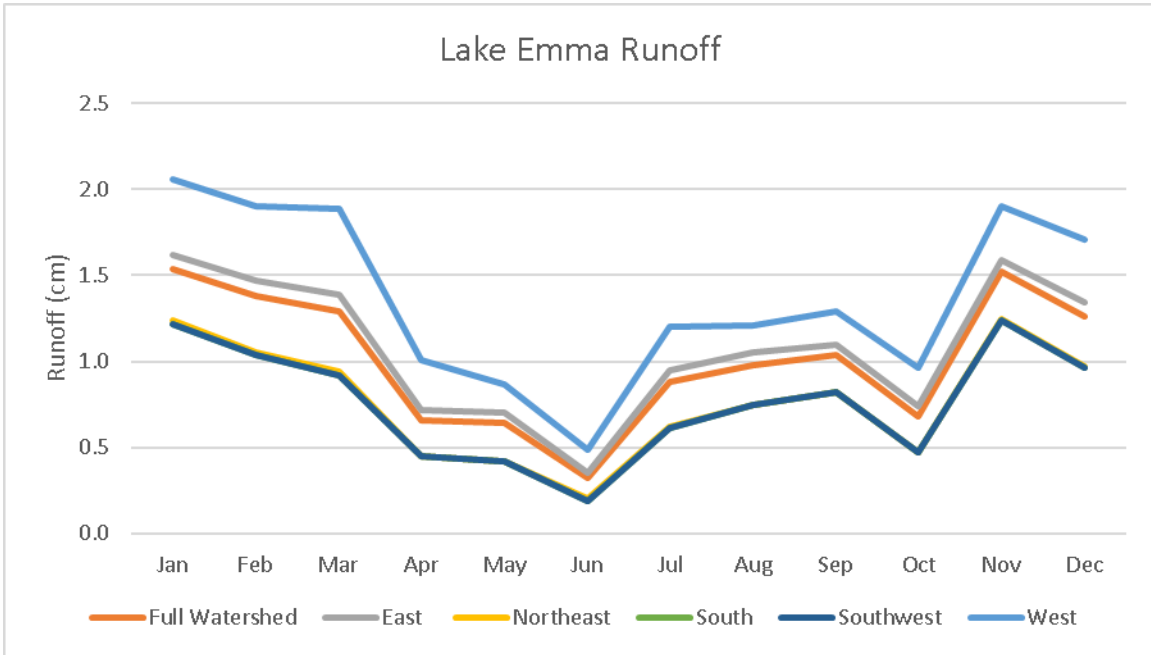
Figure 11. Average monthly runoff occurring within the Lake Emma watershed

Some variability exists between the Lake Emma subwatersheds in regard to runoff (Figure 11). In particular, the West subwatershed yields higher rates of runoff throughout the year than other subwatersheds, likely due to its increased coverage by developed land, which is more likely to include impervious landcover such as pavement. The south and southwest subwatersheds feature the least runoff, likely due to their estimated 100% coverage with forested area. This land-use type typically allows for greater infiltration of precipitation into the water table than developed land does. When direct precipitation and evaporation to and from the lake itself are factored in, Lake Emma is estimated to receive approximately 201,600 m³ or 53.3 million gallons of water a year.

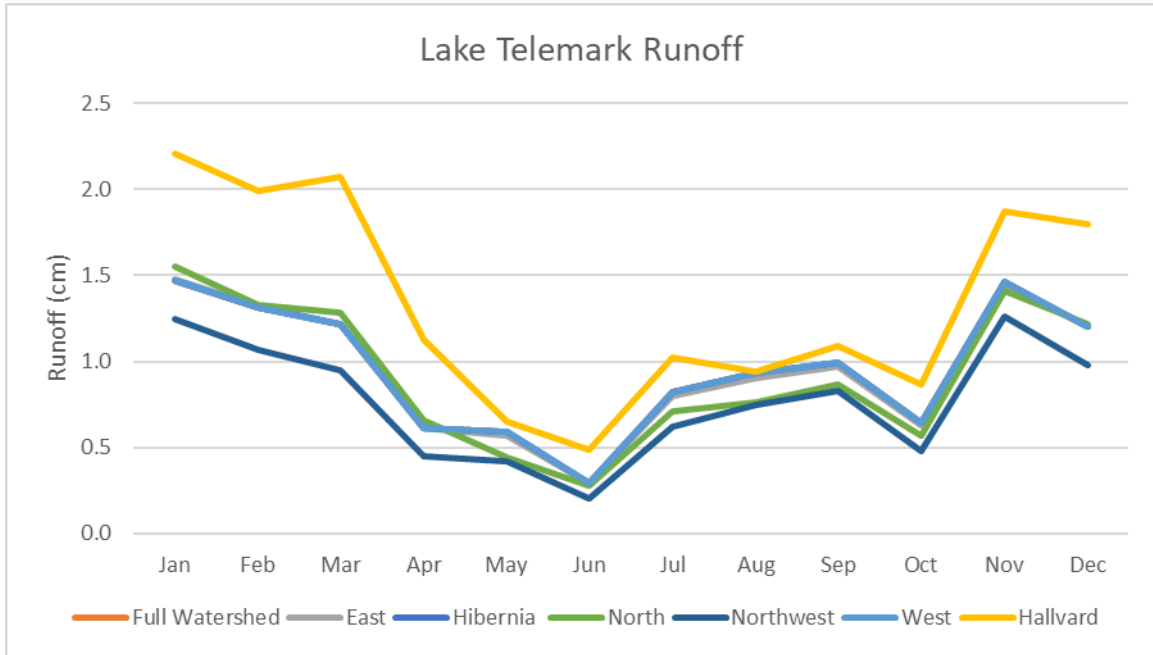
Figure 8. Average monthly runoff occurring in each sub-watershed in the Lake Telemark watershed

There is little difference between most of the individual subwatersheds in regards to runoff, with the only outlier being Hallvard. While this is the smallest subwatershed for Lake Telemark, it contains mostly urbanized areas, with little forested land or wetlands to allow rainwater to infiltrate the soil or otherwise be detained. Taking into account direct precipitation and evapotranspiration to and from the lake itself, Lake Telemark is estimated to receive approximately 3,247,800.0 m³ or 858 million gallons of water a year.

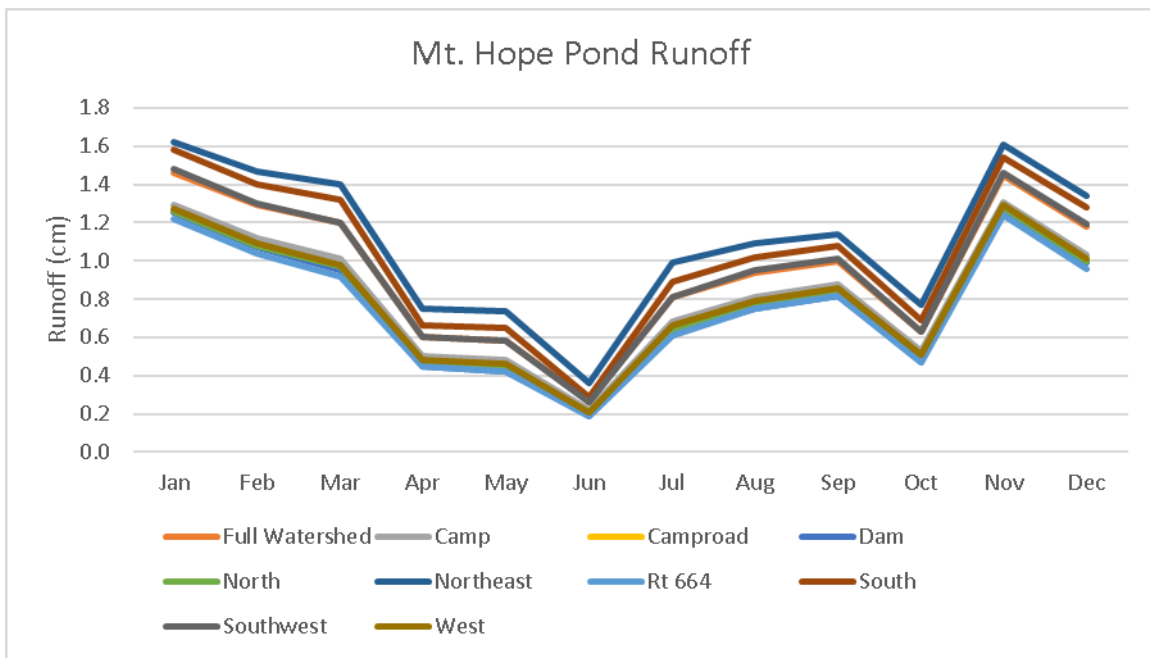
Figure 22. Average monthly runoff occurring in each sub-watershed in the Mt. Hope Pond watershed

Due to the largely forested nature of most of the Mt. Hope Pond watershed, there is, for the most part, only minor variation between its subwatersheds in regards to runoff. The northeast subwatershed, however, features the highest overall runoff, and this is likely a product of the area of bare rock it contains. This land-type is estimated to contain largely impervious cover, meaning most rainfall immediately continues downhill rather than infiltrating into groundwater. When direct precipitation and evapotranspiration to the pond itself are considered, Mt. Hope Pond is estimated to receive approximately 290,629.6 m³ or approximately 76.8 million gallons of water a year.

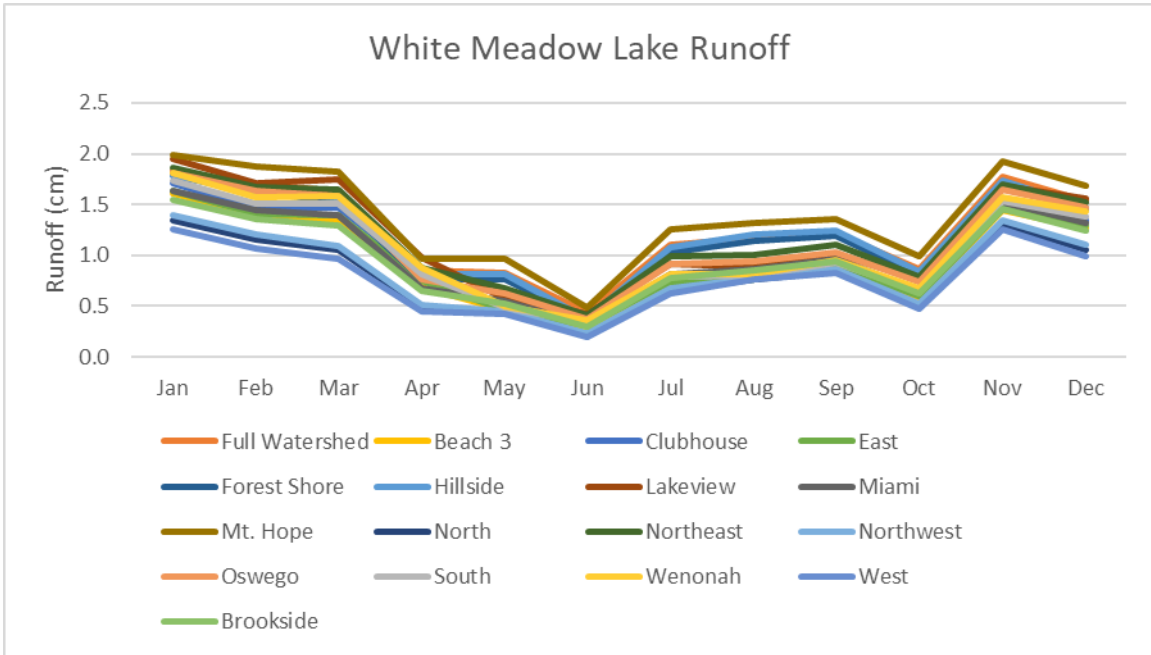
Figure 11. Average monthly runoff occurring in the sub-watersheds of White Meadow Lake watershed

Runoff for the majority of White Meadow Lake’s subwatersheds was relatively high due to the prevalence of urbanized land-use and associated impervious groundcover. The Mt. Hope subwatershed yielded the highest estimated annual runoff, likely due to it featuring more bare rock land cover than other subwatersheds. Much like urban impervious landcover, bare rock similarly allows for almost all water to run off rather than infiltrate into groundwater. When direct participation and evapotranspiration to the lake itself are considered, White Meadow Lake is estimated to receive approximately 4,264,762.9 m³ or 1,126.6 million gallons of water each year.

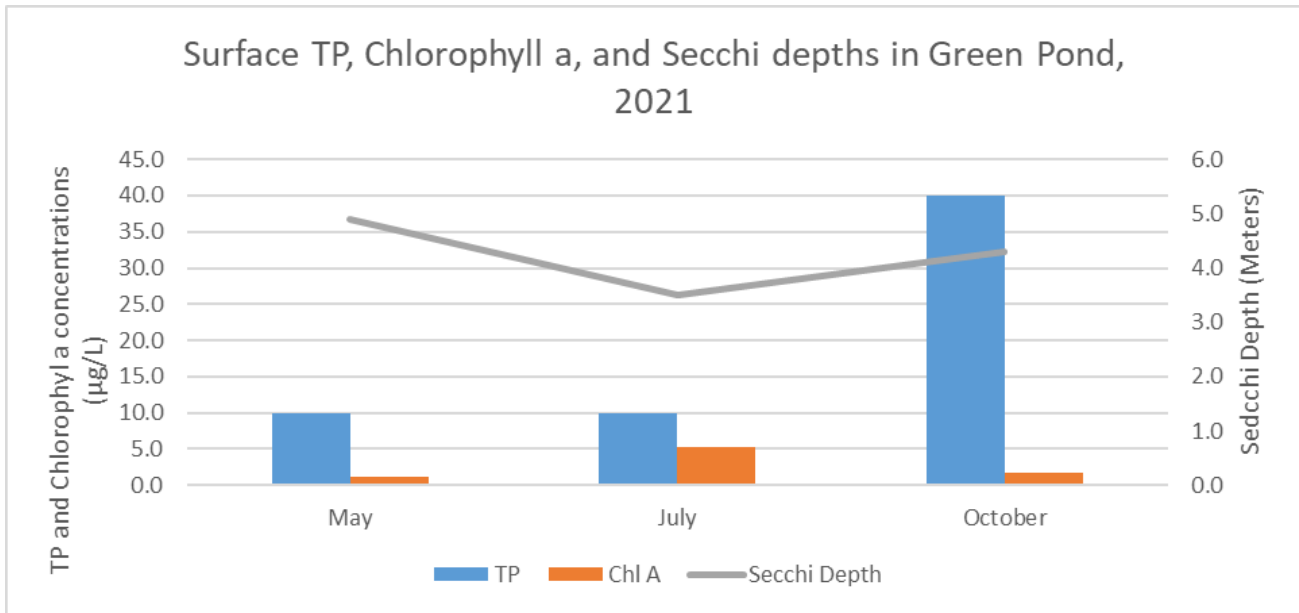
Figure 13. Concentrations of chlorophyll *a* (Chlorophyll *a*) and total phosphorus (TP), as well as Secchi depths, measured from the surface of the North station at Green Pond on three dates in 2021.

Surface and deep chlorophyll *a* concentrations were overall relatively low throughout the season, reaching a seasonal high of only 5.3 µg/L at the surface in July. It should be noted that the deep sample collected in May was slightly higher in concentration than the surface sample on the same date, suggesting a presence of deep-water algae.

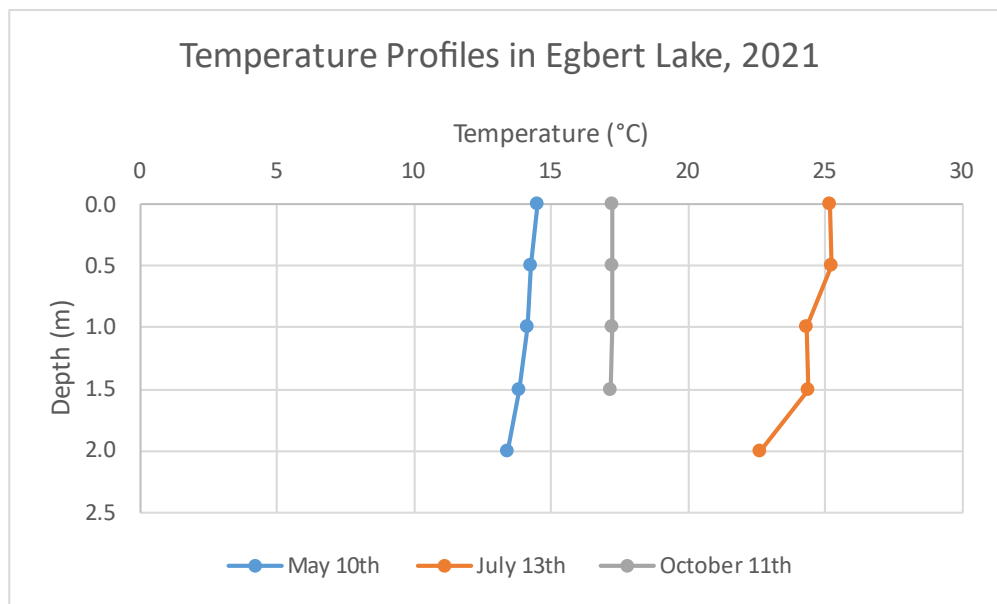
Figure 14. Temperature profiles collected during 2021 at the Dam station at Egbert Lake

Egbert Lake featured a thermally well-mixed water column during the May sampling event. Dissolved oxygen at this time was sufficient throughout the water column. During the July event, the water column was observed to feature a slight thermal gradient of approximately 2-3°C. Reductions in dissolved oxygen were also measured during this event within the bottom-most half-meter of the water column. The dam station featured a slight increase in dissolved oxygen at the very bottom of the water column, however. This may have been a product of plant or algae growth occurring just over the bottom sediments. Water clarity as measured with a Secchi disk was measured to be at least 1.5 meters during this event; plants obscured the disk before it disappeared from view due to turbidity. By September, the water column had become thermally mixed, and dissolved oxygen concentrations, while not particularly high, were sufficient for aquatic life. Secchi depths also increased during this time, measured at 1.9 – 2 meters.

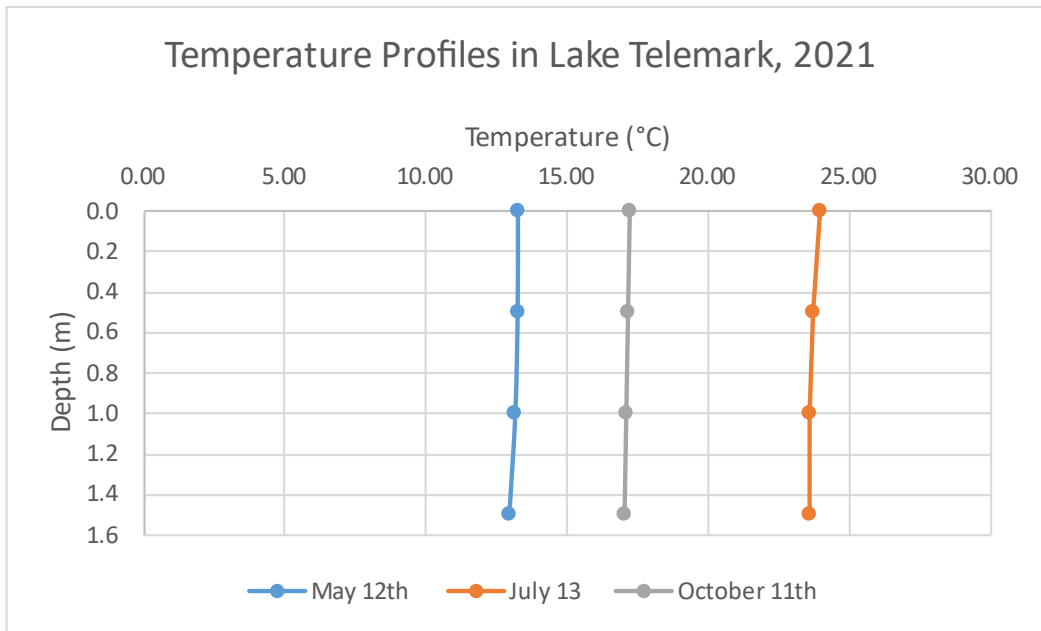
Figure 27. Temperature profiles collected during 2021 at the Dam station at Lake Telemark

Lake Telemark’s water column was well-mixed during the May event and featured supersaturated dissolved oxygen concentrations (>100%) throughout. Water clarity during this event measured approximately 1.7 meters; this dropped to 0.9 meters in July. While dissolved oxygen concentrations dropped to a range of approximately 80 – 89.5% in July, the water column remained thermally stratified. These conditions remained fairly consistent in October, although Secchi depths had increased at this time to encapsulate the full water column.

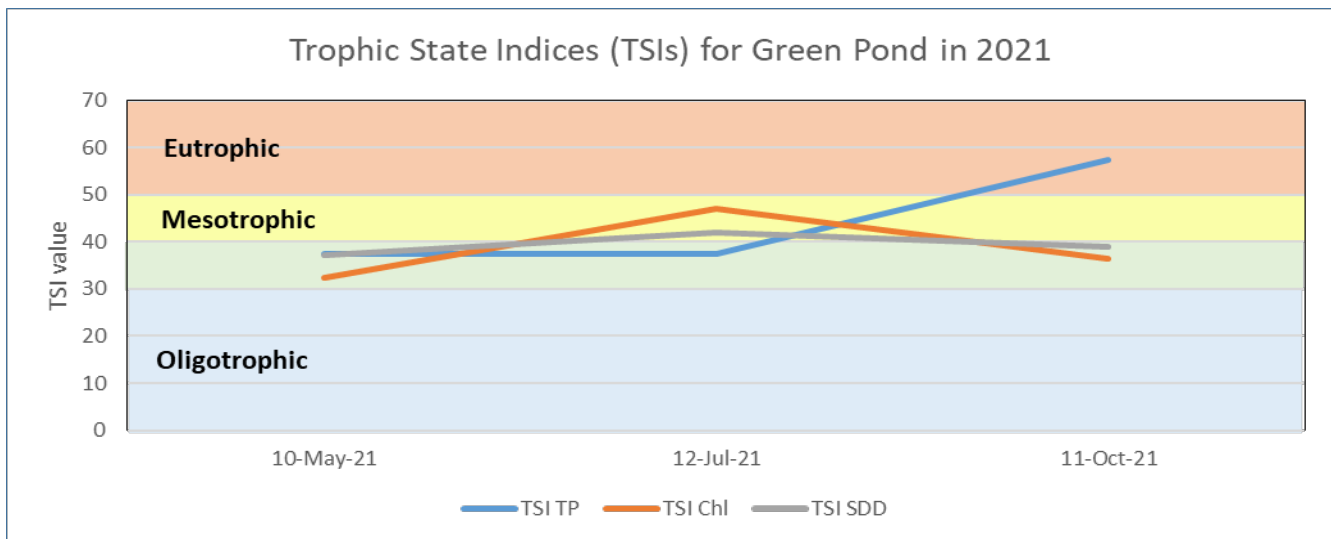
Figure 61. Changes in Trophic State Indices (TSIs) over the course of the 2021 growing season in Green Pond.

In past years, Green Pond's trophic state has largely been oligo-mesotrophic. This was largely the case in 2021, with only occasional deviations. The May event saw the total phosphorus, chlorophyll *a*, and Secchi depth components all yield TSIs between approximately 32.4 to 37.4, indicating late-Oligotrophic status. The phosphorus TSI remained stable through July, although the chlorophyll *a* and Secchi depth TSIs increased to approximately 47.0 and 41.9, respectively, indicating mesotrophic conditions. By October, these components had both dropped back to the mid-30s, indicative of oligotrophic conditions, while the total phosphorus TSI component increased to 57.3, which is more typical of eutrophic conditions. Figure 61 below displays the fluctuations in the three TSI components over the course of the season.

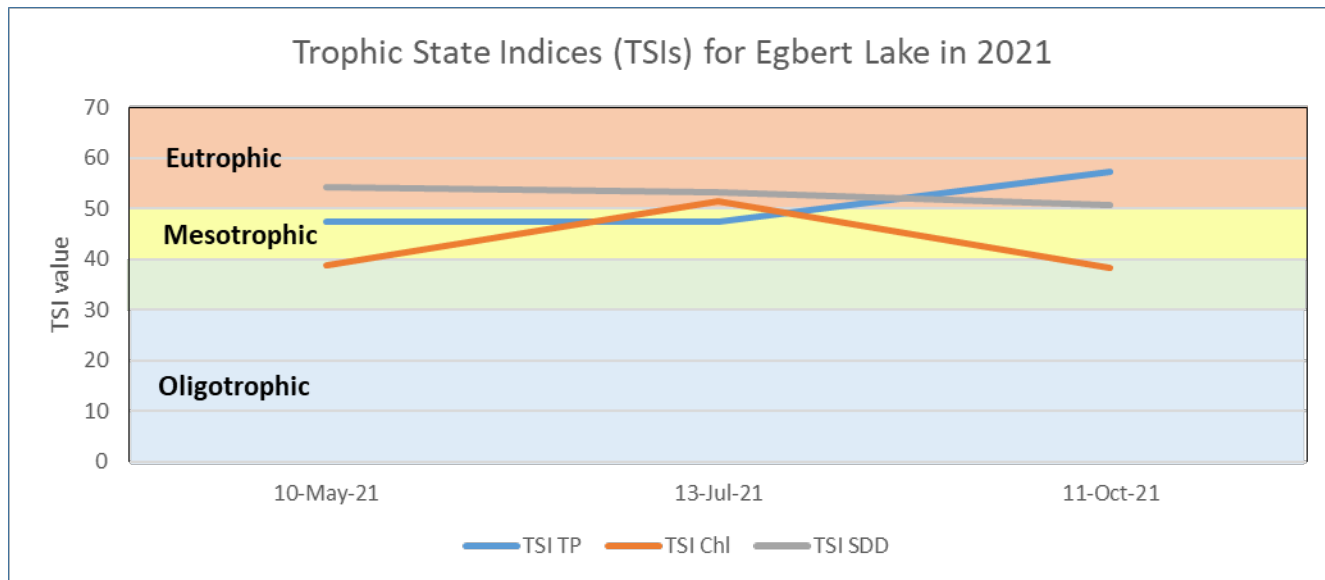
Figure 63. Changes in Trophic State Indices (TSIs) over the course of the 2021 growing season in Egbert Lake.

of eutrophic conditions. Secchi depth-based TSIs remained in the eutrophic range throughout the year; however, this is related to the lake's relatively shallow depth and at times significant plant growth which limit measurable Secchi depth. Changes in all TSI values over the course of the season are displayed below in figure 63.

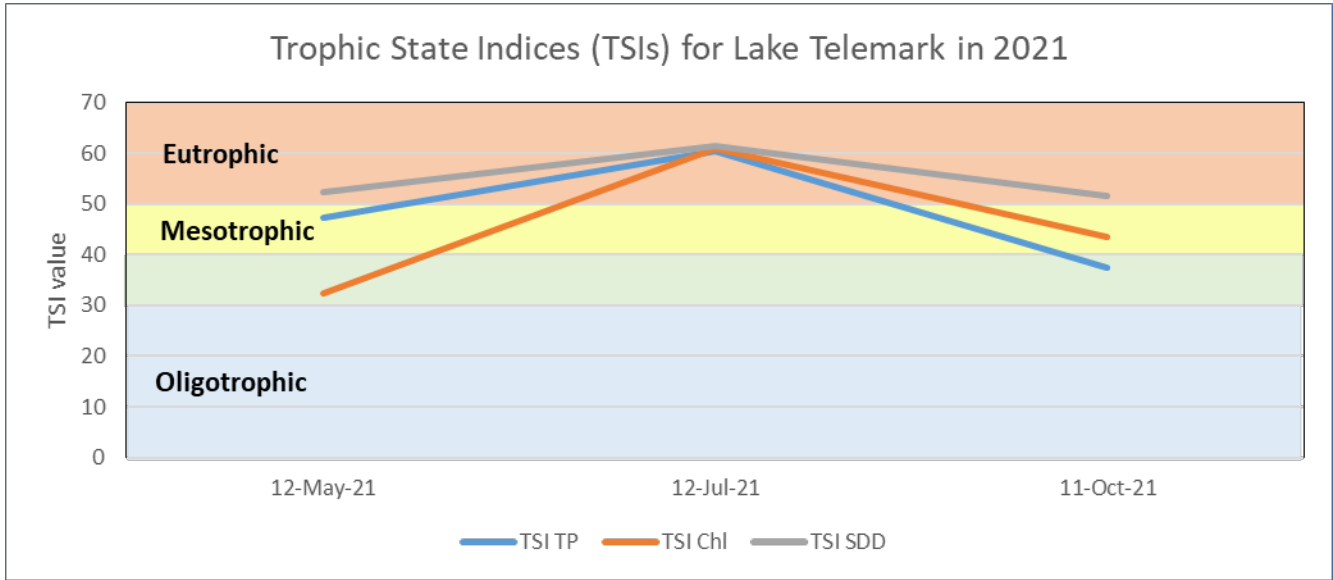
Figure 71. Changes in Trophic State Indices (TSIs) over the course of the 2021 growing season in Lake Telemark.

TSIs from the May event were variable, with the total phosphorus component yielding a value of approximately 47.3 (mesotrophic), the chlorophyll *a* component yielding a value of approximately 32.4 (late-oligotrophic) and the Secchi-based TSI yielding a value of 52.4 (eutrophic). In July, however, all values were relatively similar, ranging from approximately 60.6-61.5, suggesting eutrophic conditions, and because of the alignment of the indices indicates this is a more representative of growing season trophic state. By October, the total phosphorus-based TSI had dropped to approximately 37.4, suggesting late-oligotrophy, while the TSI for chlorophyll *a* dropped to approximately 43.4, indicative of mesotrophic conditions. The Secchi-based TSI stayed within the range indicating eutrophy, at approximately 51.2. Variations in TSI values throughout the year are displayed in Figure 71 below.

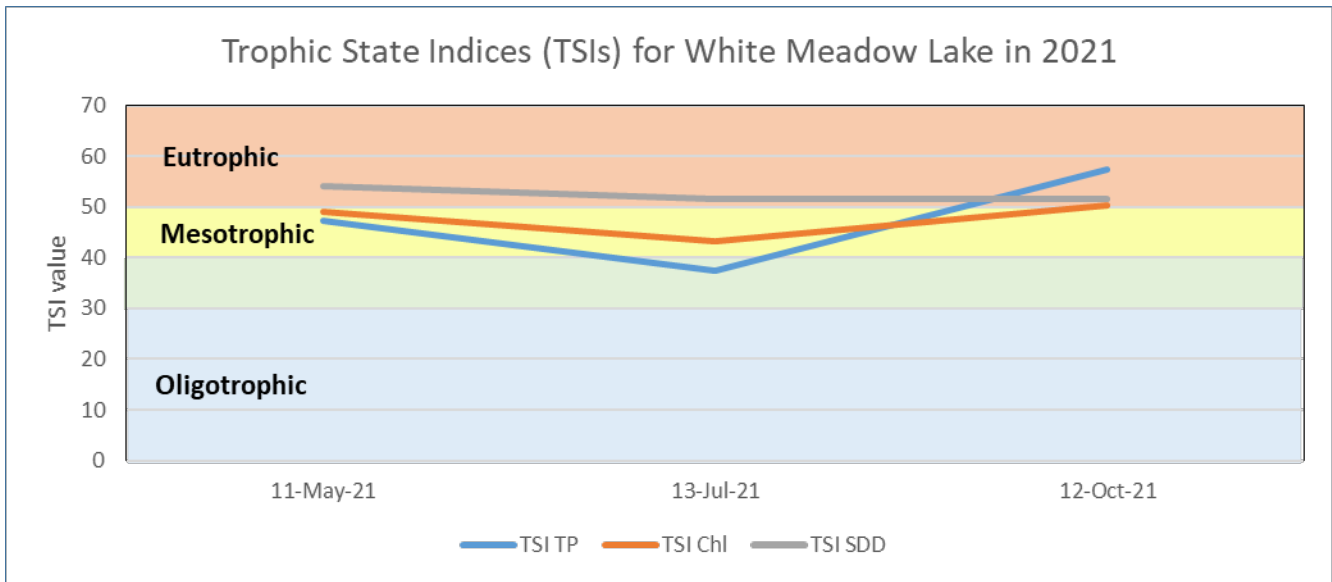
Figure 77. Changes in Trophic State Indices (TSIs) over the course of the 2021 growing season in White Meadow Lake.

indicative of late-oligotrophic conditions, while the chlorophyll a-based TSI value remained within the mesotrophic range at approximately 43.2. Both of these TSI components increased to be consistent with eutrophic conditions in October, with total phosphorus yielding a value of approximately 57.3 and Chlorophyll a yielding a value of approximately 50.2. Figure 77 below displays the variation in TSI values over the course of the 2021 growing season. The increase in late season phosphorus likely represents seasonal senescence and decomposition. Management efforts seem to be effective at limiting phosphorus concentrations until fall turnover.

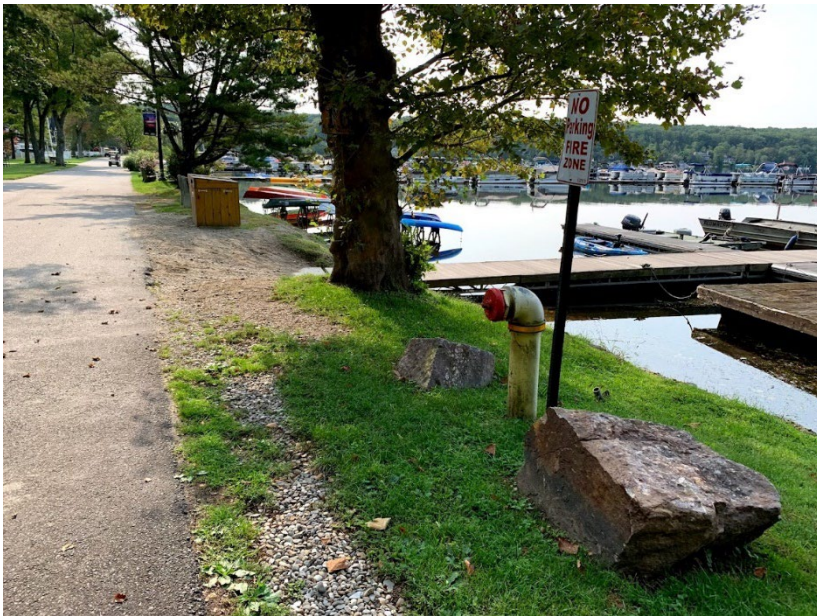
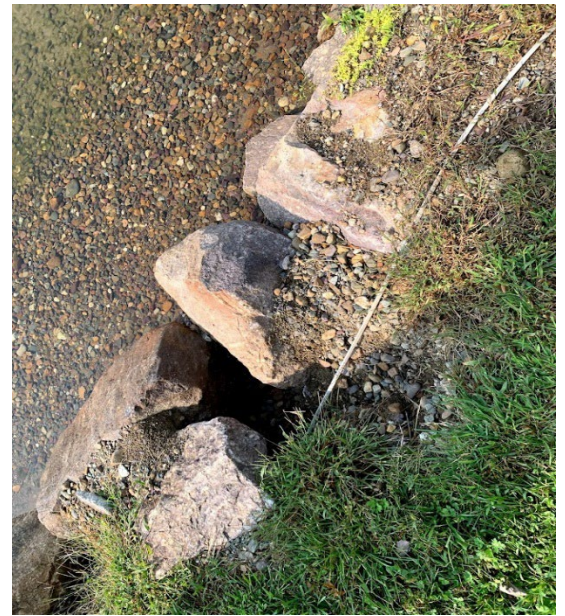
Photos 1-2: Dawson Drive, grass patches and residential docks along the Northern shoreline of Green Pond (left) and stone wall erosion (right).

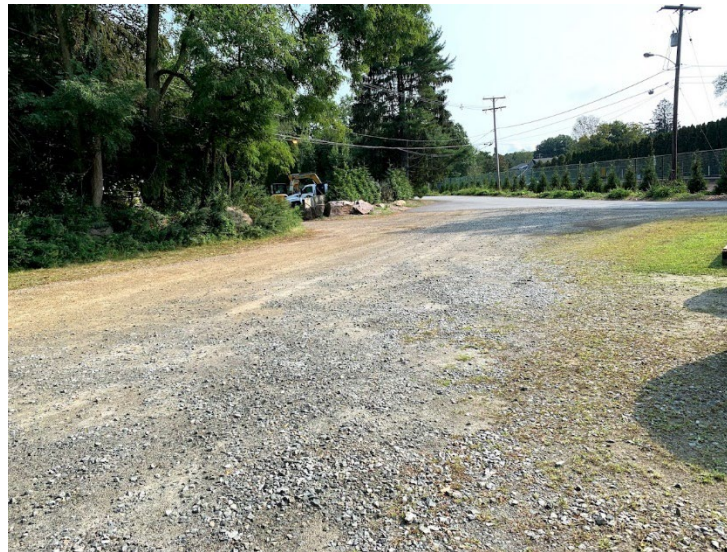
Photo 3: Gravel parking lot facing the North and the entrance Green Pond Maintenance Building

Near the intersection of Cliffside Road and West Shore Road, there is a large gravel parking lot located at the base of the elevated ridge and treeline that runs along the western shore of the lake. This site receives runoff from the ridgeline, flowing towards the lake to the southwest, and from the adjacent grass areas. The Green Pond maintenance and groundskeeping buildings are just to the north of this lot and any materials such as mulch, soil or other organics held there may contribute to nutrient input flowing towards the lake during rain events.

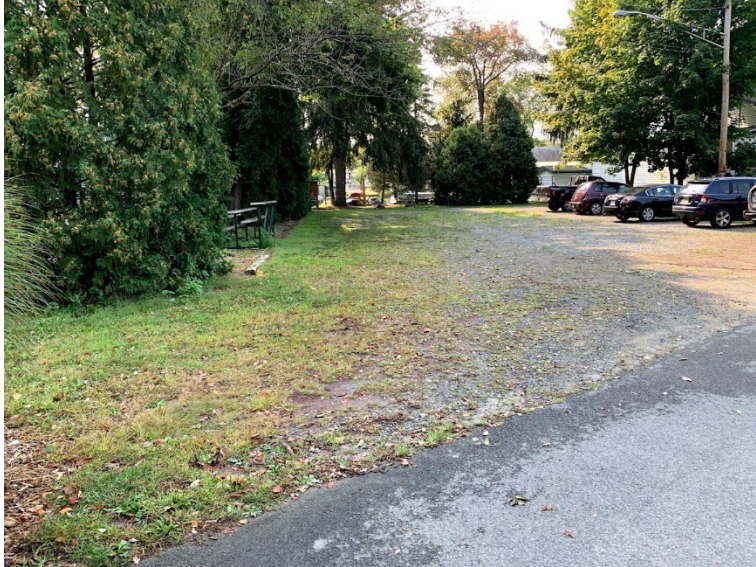
Photo 4: Small gravel parking lot to the south of Tennis courts along Cliffside Road

Immediately south of the community tennis courts, located between Cliffside Road and Bonnie Brae Road, is a gravel parking lot that is roughly 100 feet by x 50 feet in size.

Recommendation Site 3: Similar to the recommendations for the adjoining parking lot mentioned above (Site 2), this small gravel lot could be included in the drainage area of a bioswale or be a good location for a rain garden. Vegetation has started to grow through and reclaiming part of the lot along the northern side and the implementation of a rain garden there could help mitigate runoff from the nearby roads and the tennis courts. Creating a depression in the lot to direct water to a low point, paired with planting shrubs, perennials and other native plants would help mitigate the impacts of the nearby impervious surface and minimal stormwater drainage at present. An additional recommendation could be the conversion of the impervious gravel road and parking lot to an underdrained porous surface. This would provide for filtration and removal of a potential sediment and nutrient source.

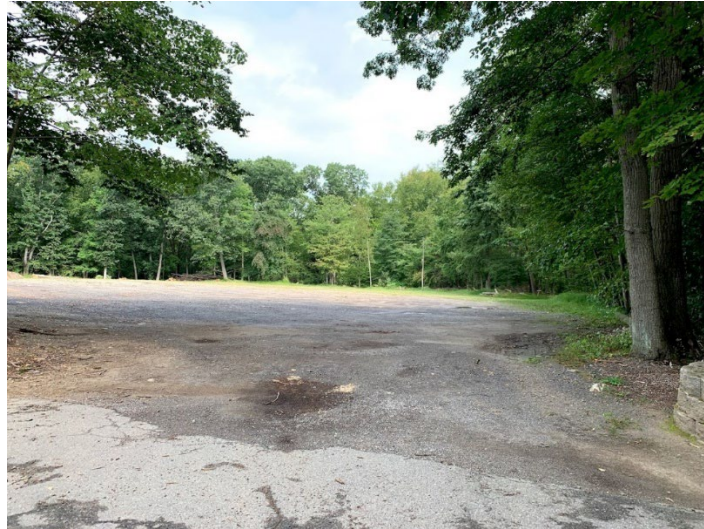
Photo 6: Camp Winnebago gravel Parking lot, facing N.

A clearing of trees and a large gravel parking lot are located near the main cabins at the entrance of Boy Scouts of America Camp Winnebago. The lot is approximately 48,000 square feet in area and connects to Winnebago Road. The lot shows signs of washed-out ruts and pothole depressions due to surface flow. Improving drainage in this parking lot would not only improve the condition of the parking surface, but also minimize loose gravel and sediment transportation during storm events.

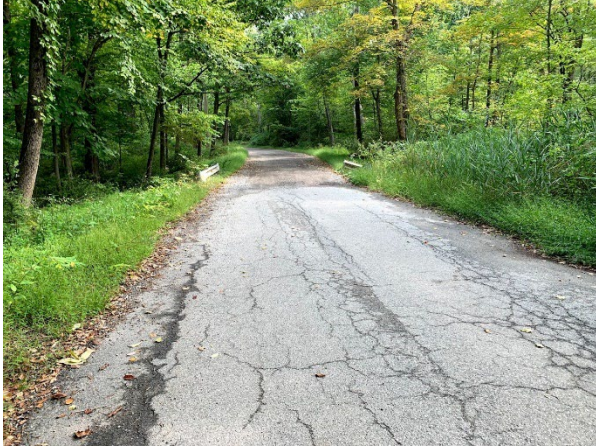
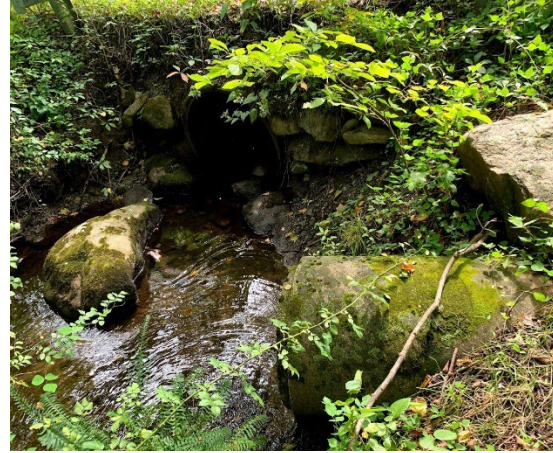
Photos 7-8: Timberbrook Road and sediment and gravel deposition in nearby creek

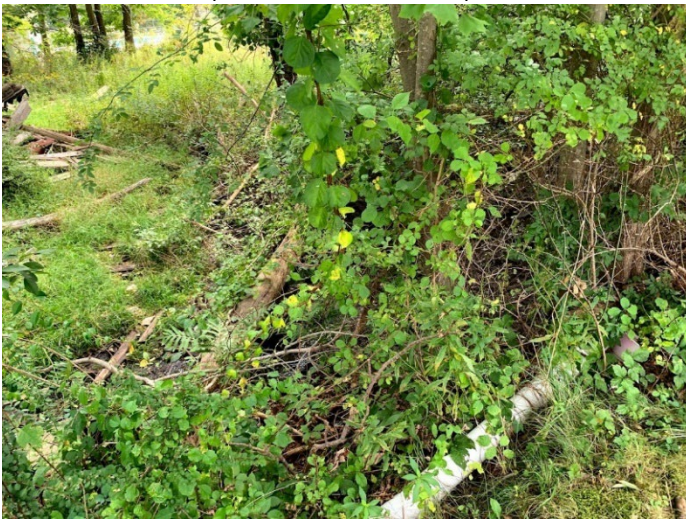
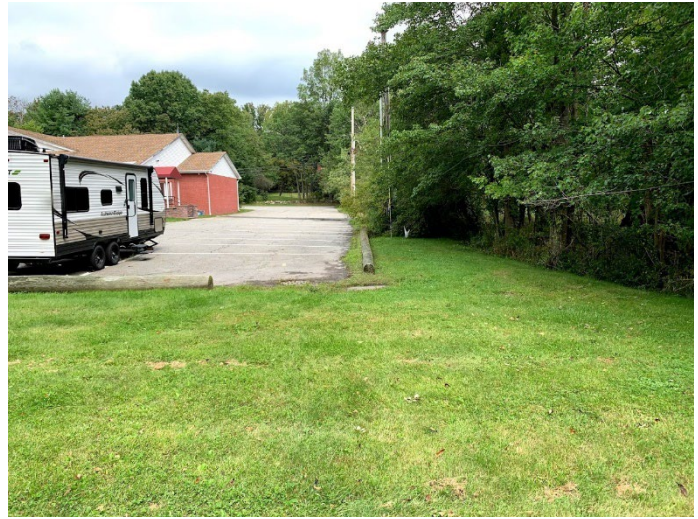
Photos 9-10: Marcella Fire Department woodlot and southern parking lot.

Marcella Fire Department, located along Upper Hibernia Road, has a parking lot, grass lawn and adjoining wood lot identified as areas of potential improvement. The parking lot and grass areas could provide space for BMPs that reduce sheet flow coming off the asphalt and mowed lawn. The wood lot has a slight depression compared to the surrounding area and was saturated with water during the field visit. In its current state the vegetation is a dense understory thicket with woody debris.

Recommendation Site 7: The recommendation for this site is to take advantage of the natural low point in the woodlot and create a bioswale or other bioretention area. This location already has a gradually sloping vegetative buffer between the impervious area and the recommended best management practice. Removing some of the downed woody debris, creating a bioswale and populating it with more water tolerant perennial plants could be an effective usage of this currently unused woodlot. This option would also minimize reducing parking space in the fire department's parking lot. Any runoff from the residential houses that back up to this woodlot to the east would also be slowed and filtered in addition to flow from the road and fire department.

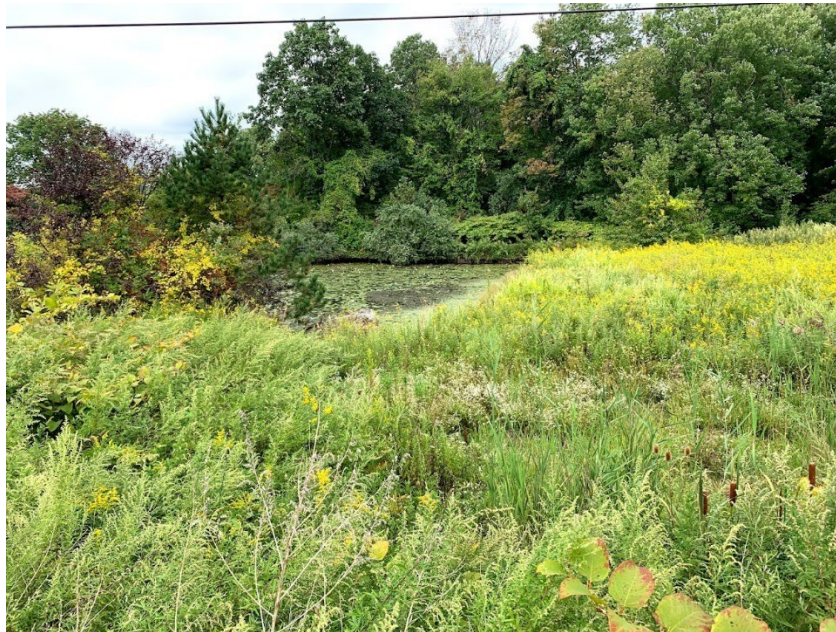
Photo 11: Small Inlet Pond across from Lake Emma

On the northern side of Green Pond Road directly across from Lake Emma, there is a small inlet pond approximately 0.15 acres in size. The pond is entirely covered in aquatic vegetation, predominantly white-water lily (*Nymphaea odorata*). There is a vegetated buffer between this pond and the road, which is beneficial for reducing pollutants and runoff. There is a connection between this water feature to Lake Emma, however when one flows into the other is unknown. This pond could be a source of nutrient input to potentially the lake as well as waterbodies within the Township. Prior to implementing any recommendation and estimating nutrient removal efficiencies the interaction between this pond and Lake Emma needs to be investigated and understood.

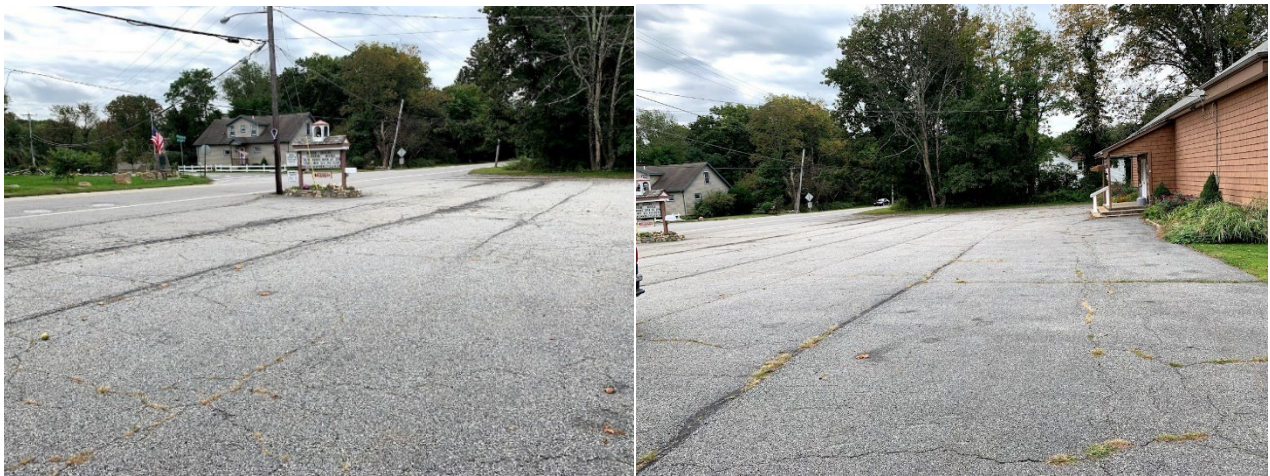
Photos 12-13: Marcella Community Club parking lot along Green Pond Road

The Marcella Community Club, located at the intersection of Green Pond Road and Upper Hibernia Road, has an asphalt parking lot measuring approximately 75 feet by 135 feet. There were no stormwater drains noted during the site visit and a large, and relatively flat, impervious surface could present challenges with drainage during rain events.

Recommendation Site 10: The recommendation for this site is to discount the impervious surface. This could be completed in a variety of ways depending on the use and subsurface soil conditions. The installation of porous pavement vegetated depressed parking lot islands, and/or manufactured vegetated filter boxes such as the Filterra could be possible best management practices implemented at this site. These could also be installed in combination with each other to maximize the removal efficiency.

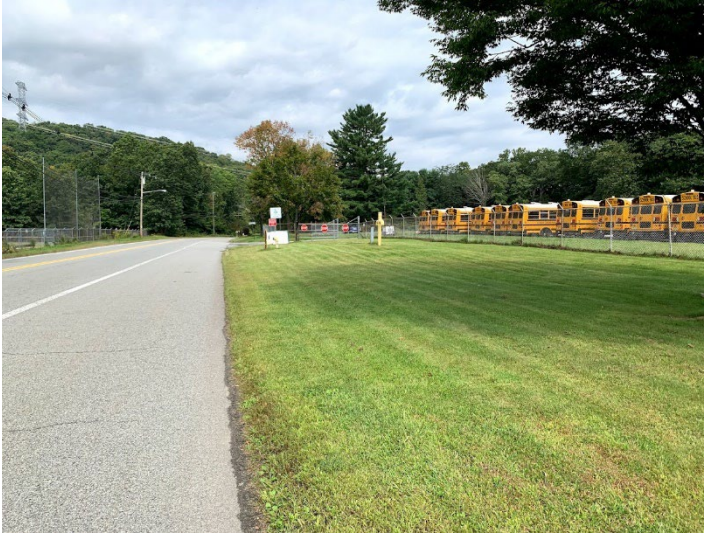
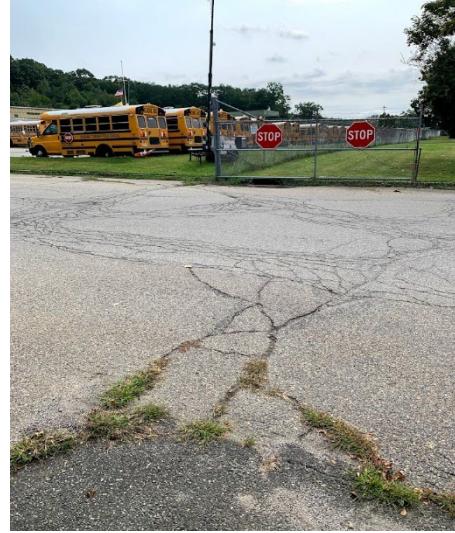
Photos 14-15: Grass field separating Green Pond Road and Bus Garage parking lot & entrance to DPW parking lot

The Department of Public Works (DPW) and Bus Garage have several large grass areas around the perimeter of the parking lots and along Green Pond Road. The entrance of the DPW parking lot has a series of stormwater drains along both sides that take surface flow from the adjoining lots and grass surfaces. The high concentration of impervious surfaces paired with maintained lawn areas provide a potential for a variety of treatment to reduce runoff and pollutants from entering the stormwater system and ultimately Hibernia Brook and Telemark Lake.

Recommendation Site 11: The first recommendation (Site 11A) for this site is the implementation of a bioretention system in the grassed area between the parking lot and Green Pond Road. Providing a sheet flow connection from the road and parking lot, retaining the water and filtering it through native vegetation and soil media to use and remove nutrients from the stormwater. Another recommendation (Site 11B) would be the conversion of the existing impervious surfaces to a porous material or reducing the surface area of impervious surfaces directly connected to the stormwater pipe without treatment. Additionally (Site 11C), the installation of a manufactured treatment device or multiple devices along or in line with the existing stormwater system would provide treatment of additional runoff.

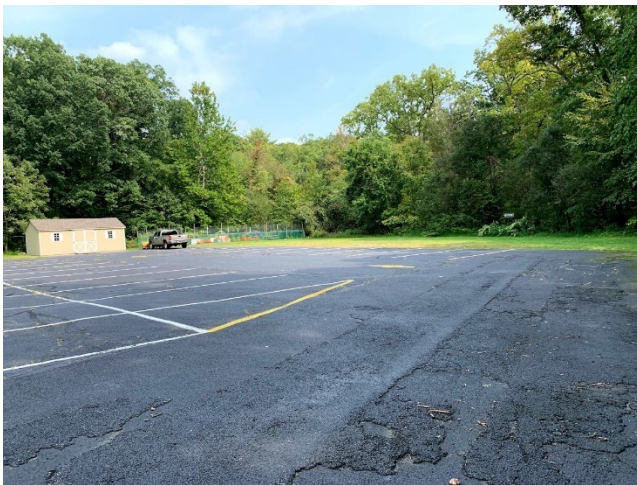
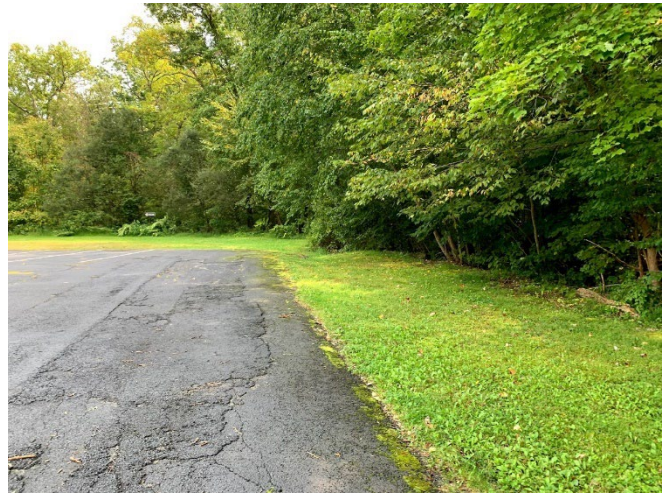
Photos 16-17: Holy Trinity Lutheran Church rear parking lot and buffering woodlot

Holy Trinity Lutheran Church is located near the intersections of Colonial Road and Green Pond Road. It has a front and rear parking lot connected along the southern side of the building. Along the perimeter of the rear lot is a grass corridor and wooded area. The southern entrance to the parking lot has a stormwater drain that directs water into a drainage feature within the treeline. Several small clearings in vegetation exist as access paths into the woods.

Recommendation Site 13: The recommendation for this site would be the conversion of the existing impervious surfaces to porous surfaces and/or reducing the area of impervious surfaces.

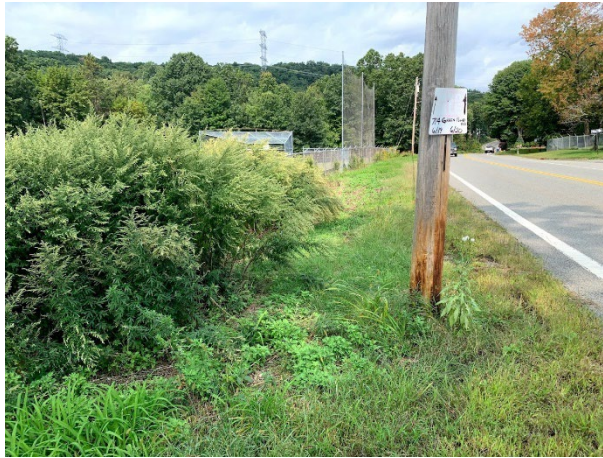
Photo 18: Grass section between Hudsonia baseball field and Green Pond Road, facing north

Across the street from the DPW building and bus garage, there is a sports field complex called Hudsonia Field. The complex includes gravel parking lots and access roads, soccer fields, and a baseball field. The complex drains directly to Hudsonia Pond or Hibernia Brook which is the primary inlet into Telemark Lake. During the site visit, ruts and washout depressions were observed in the grass section bordering Green Pond Road.

Recommendation Site 14: The recommendation (Site 14A) for this site includes increased vegetative cover and reduced mowing to create a vegetative buffer and filter strip within a stretch of meadow grass. This BMP would not impede access to the sporting fields, would minimize groundskeeping and would add structure to the eroding land with increased root density. Planting native perennial plants would also create suitable habitat for native fauna as well as contribute to the aesthetic value of the park. The installation of management practices (Site 14B) within the gravel parking and access areas such as vegetated pavers, redirecting of flow, and buffer strips to reduce the formation of gullies and transport of sediment downstream.
