AN ASSESSMENT OF THE LAKES AND WATERSHEDS OF ROCKAWAY TOWNSHIP

TOWNSHIP OF ROCKAWAY, MORRIS COUNTY, NEW JERSEY

DECEMBER 2022

PRINCETON HYDRO, LLC
1108 OLD YORK ROAD, SUITE 1
POST OFFICE BOX 720
RINGOES, NJ 08551

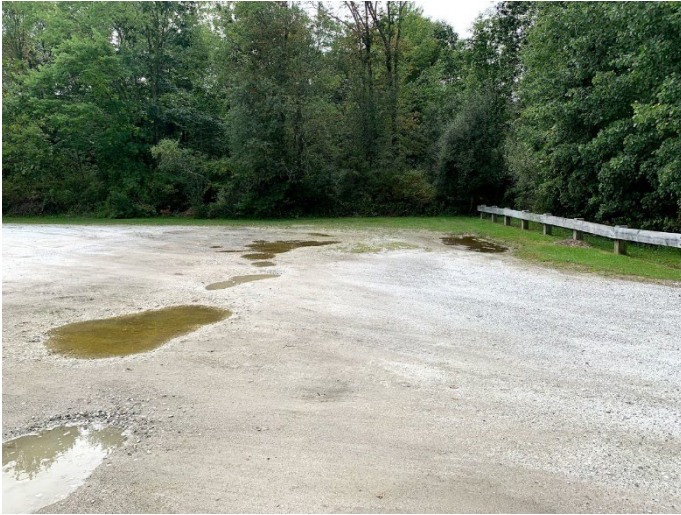
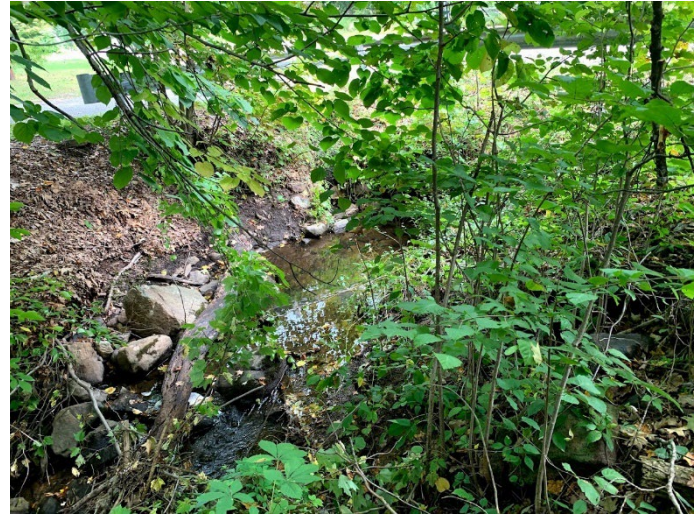
Photos 19-20: Norway Field parking lot & small creek along the western side of the park

Norway Field consists of a gravel parking lot and grass athletic field with a small creek along the western portion of the park. There is a gradual slope from Green Pond Road down to the parking lot and water from the road flows towards the lot and creek. During the site visit large potholes of water were evident throughout the lot. The woodlot buffering the stream has a walking path that is cleared of vegetation. The creek appears to be stable with boulders throughout and vegetation along the banks.

Recommendation Site 15: The recommendation at this site is the installation of best management practices within the gravel parking and access areas such as vegetated pavers, redirecting of flow, and buffer strips to reduce the formation of gullies and transport of sediment downstream. This BMP would help add stability to the parking lot and eliminate stagnant water collection in potholes, increase vegetation cover and reduce stone and sediment from washing into the nearby creek.

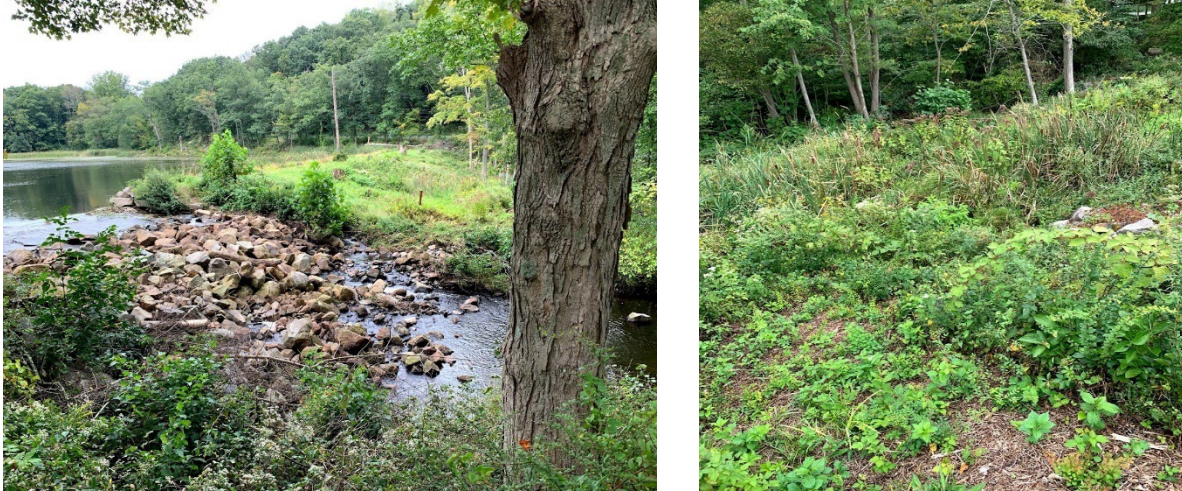
Photos 21-22: Hiberina brook outflow along Lake Ames impoundment (left) & vegetation along backside of the impoundment

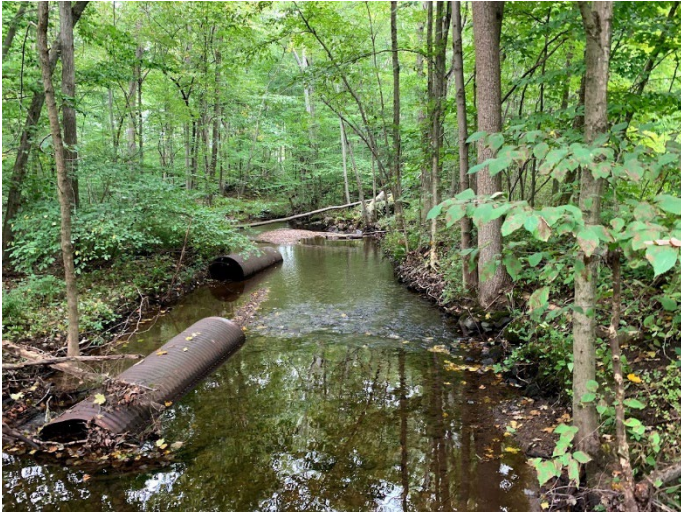
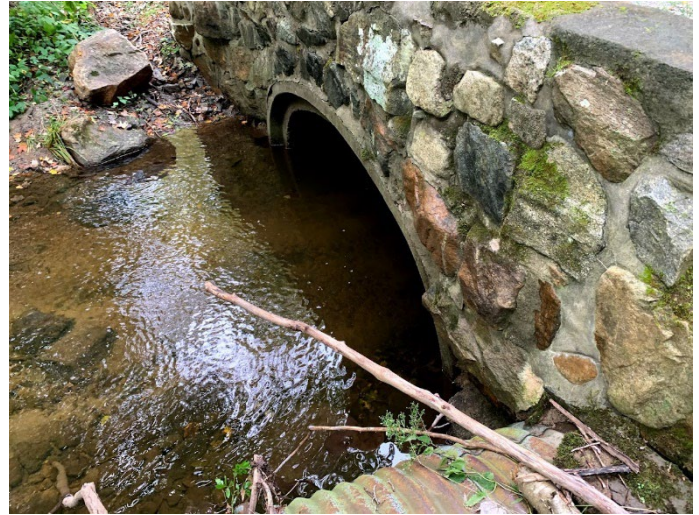
Photos 23-24: Unnamed tributary with remnants of piping (left) & culvert channel crossing under Snake Hill Road (right)

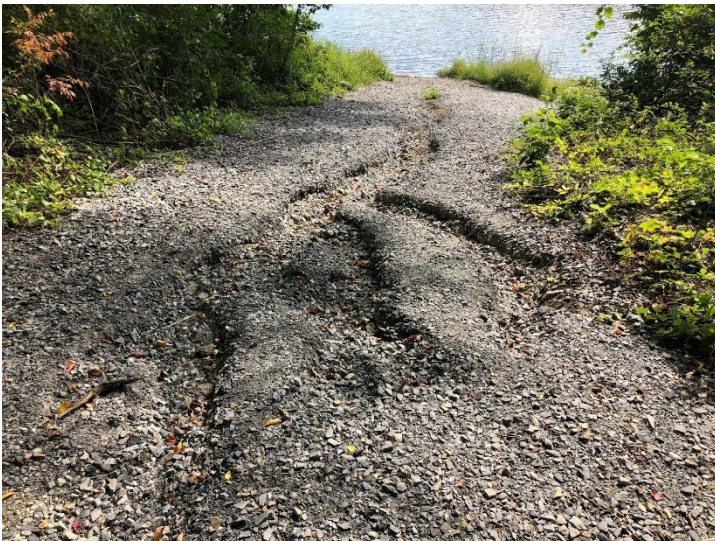
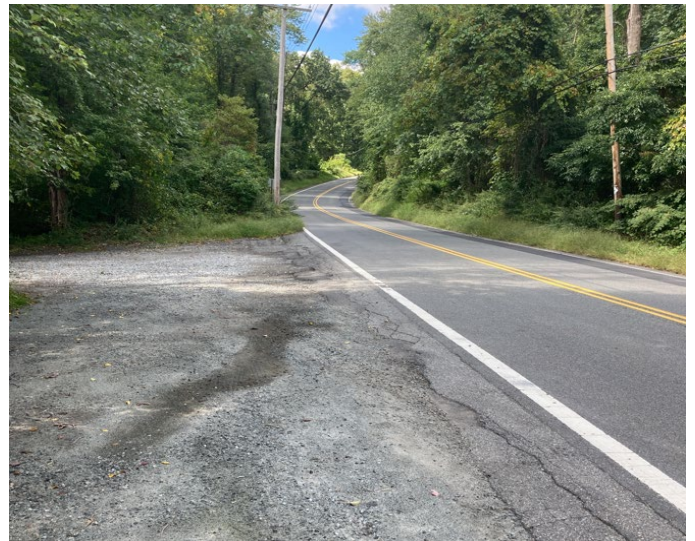
Photos 25-26: Signs of Erosion on boat launch area (left), and Mount Hope Road drainage leading to area (right)

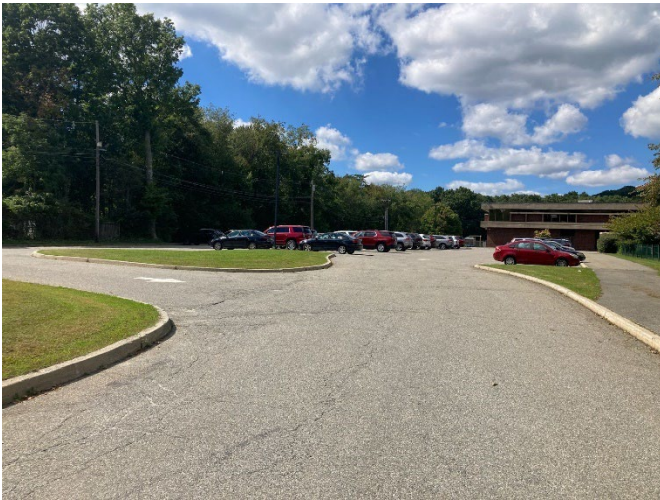
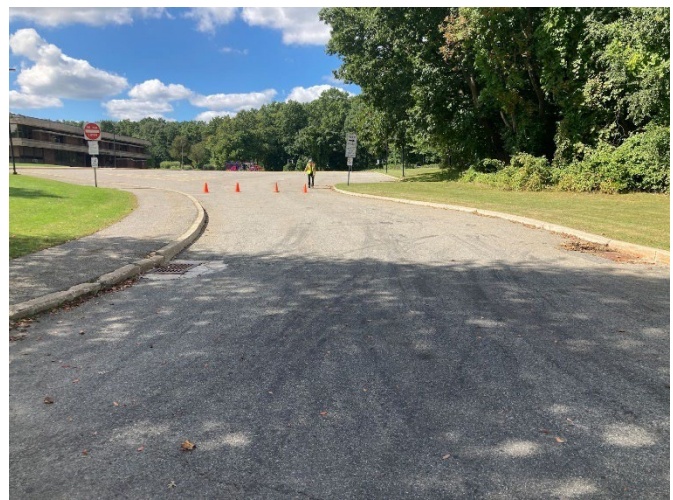
Photos 27-28: Two Potential BMP locations at Dwyer Elementary parking lot entrances

Catherine A Dwyer Elementary School is located off of Mount Hope Avenue. The school contains two asphalt parking lots which contribute to the stormwater system running under Mount Hope Avenue via an existing stormwater piping and inlet system located within the parking lots. This stormwater system conveys the stormwater runoff from these parking lots, adjacent residential lots, and street drainage to its discharge into Mount Hope Lake.

Recommendation Site 21A: One recommended BMP for this site would be to intercept the surface stormwater runoff from the parking lots with a porous pavement system at the parking lot entrance, down-gradient of the parking lot areas. Portions of the entrance driveways of the asphalt parking lots would be removed and replaced with a porous pavement system containing subsurface storage options such as pipes or subsurface chambers. Representative areas for the BMPs can be shown in Photos 27-28 above. These BMPs would intercept the surface and piped runoff from the parking lots, store it within the BMPs piping or chambered systems, and discharge back into the existing street drainage system. These practices could also intercept some of the street drainage to infiltrate and store it within the subsurface systems, for additional stormwater volume management. Stormwater runoff reduction into the lake via BMP filtration and storage are beneficial as they allow for the site and lake to become more resilient to larger storm events caused by climate change. Additionally, these porous paving systems could be applied in a modular way to various parking spaces around the parking lot, allowing for a greater volume of runoff to be treated at this location from those areas as well.

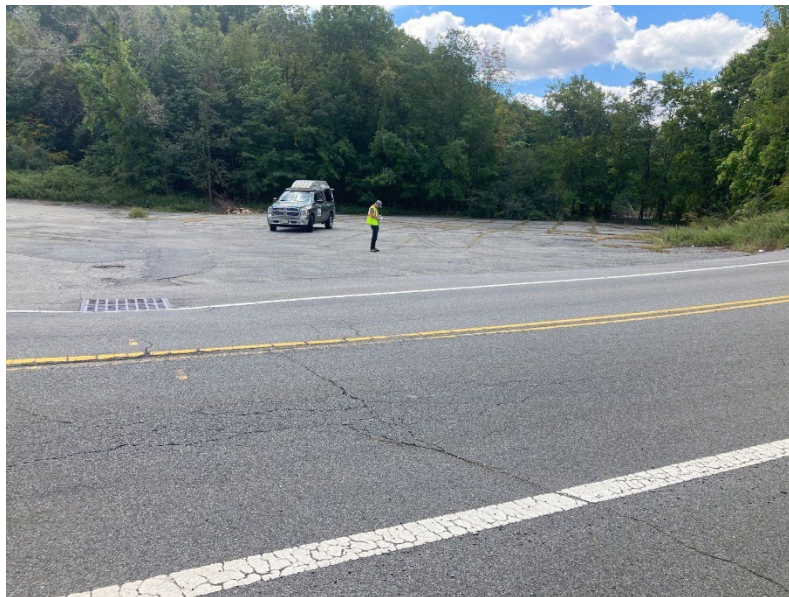
Photo 29: Mount Hope Road roadside inlet and part of surrounding parking lot area

Along Mount Hope Road and to the west of White Meadow Lake is a vacant parking lot. This parking lot's drainage system includes two catch basins and associated piping to collect and convey the runoff from the parking lot and parts of Mount Hope Road before discharging directly into the lake, as shown in Photo 27 below. Multiple stormwater management measures would be implemented at this location.

Recommendation Site 22A: This porous pavement system will intercept the two-inlet drainage system before it discharges into the storm pipe on the north side of Mount Hope Road. This BMP will be equipped with an underground piping or chamber apparatus and gravel storage to properly contain and convey the runoff draining to this system. Additionally, the porous pavement system will intercept surface runoff from parts of Mount Hope Road, lessening stormwater impact on surrounding areas. The reduction of impervious area draining into the lake from this location will improve the water quality of the lake by reducing contaminant contribution stemming from Site 22, since the site will have an area to infiltrate the stormwater directly into the ground. This BMP improvement also allows for more local stormwater storage for this watershed, reducing stormwater loading further downstream. This is an added measure to protect against increasing storm intensity due to climate change and provides an added area of storage within this watershed's drainage system.

Recommendation Site 22B: In addition to the porous paving system installed at this location, part of the asphalt bordering Mount Hope Road could be removed, with a vegetated bioretention strip installed in place instead. A location such as Photo 29 shown above would be able to have part of the impervious area of the parking lot and the impervious area of Mount Hope Road split by a bioretention stormwater storage system. This system would be able to accomplish the same runoff filtration and storage goal as the porous paving system, with an added vegetated component to increase filtration. These systems would also be hydraulically connected and

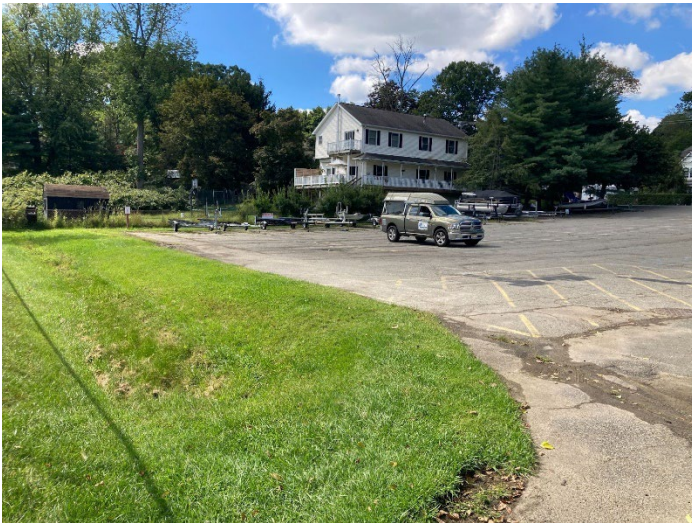
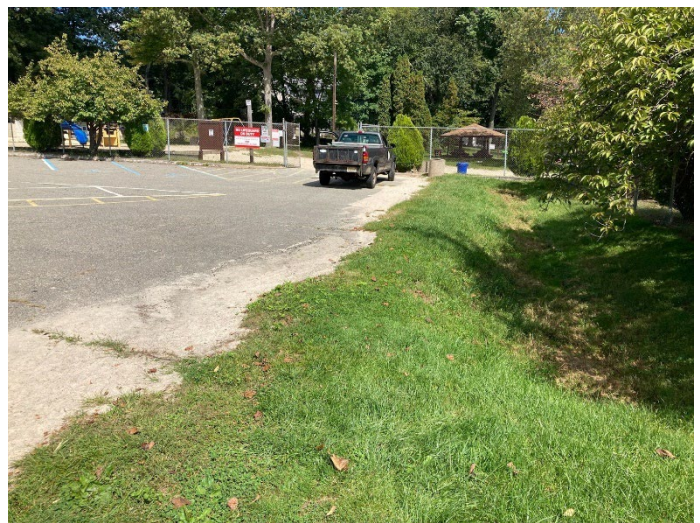
Photos 30-31: Parking lots and grassed swale conveyance systems

Site 23 are the two parking lots located at the Beach 2 boat launch of White Meadow Lake, between West Lakeshore Drive and the shoreline of the lake. The discharge channel from Mount Hope Lake splits the two parking lots. These parking lot areas are sloped towards the lake and contain grassed swale conveyance systems which empty into the stream system and thus the lake. The parking lot areas are primarily used in the summer months, when the beach area is more active, and contain no other drainage system other than the grassed swales. Refer to Photos 30 and 31 below for the location of the swales pertaining to the parking lot.

Recommendation Site 23A: The conversion of the grassed swale into a rain garden would provide greater nutrient uptake and sediment removal. Refer to Figure 82 below for a schematic of the rain garden locations pertaining to the river and lakefront area.

Recommendation Site 23B: In addition to the rain garden conversion, porous paving strips could be installed in the middle of the parking lot. This would add an additional stormwater filtration and storage element to the site. This measure also extends the life of the rain garden and prevents rain garden erosion/clogging, as the stormwater runoff velocity and volume traveling to the rain garden is reduced when passing over the porous paving strip. Refer to Figure 82 below for a schematic of the porous paving strip locations pertaining to the river and lakefront area.

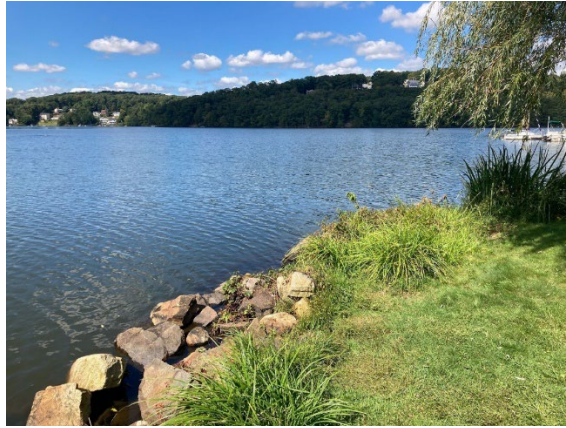
Photo 32: Area for potential shoreline restoration along Site 24

Site 24 is the White Meadow Lake Country Club and grounds surrounding the building. This building is located on the southeast end of White Meadow Lake, adjacent to the dam. This area contains a parking lot, boat launch, boat docks, and a grassed area that borders the lake. The manicured lawn runs directly up to the shoreline of the lake with minimal shoreline vegetation separating the lawn from the lake, as shown in Photo 32. Because of this, pollutants and sediment drain directly to the lake from the lawn with minimal interception or nutrient filtration from shoreline vegetation. This area presents an opportunity for shoreline improvements to prevent sediment and pollution addition into the lake.

Recommendation Site 24: Improvements to the shoreline vegetation would reduce nutrient loading to the lake from this location, as an improved vegetated shoreline will provide a buffer to filter and/or use these nutrients. Additionally, shoreline herbaceous vegetation will stabilize the soil and provide a deterrent to geese and other animals from accessing the lake at these locations. Shoreline health can also be improved by maintenance measures, such as leaving a 10-15 feet unmowed border along the shoreline area.

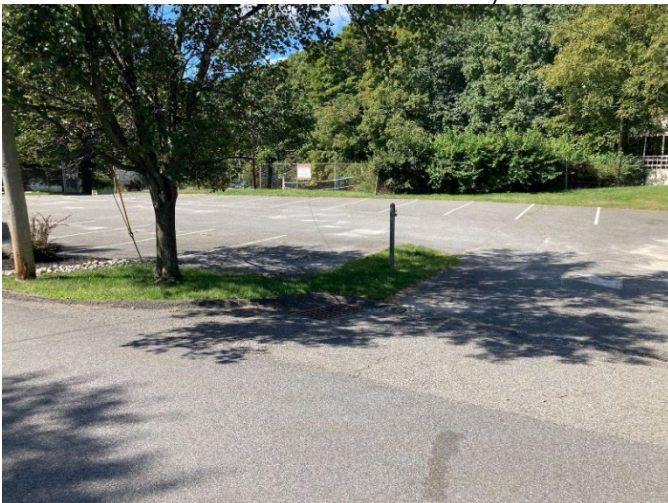
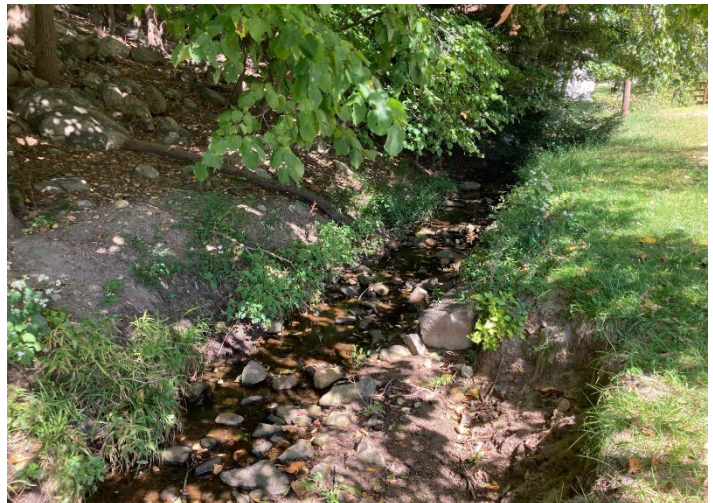
Photos 33-34: Parking Lot- Potential Porous Paving Location and Stream Channel on site

Site 25 is located along the shoreline in the northeast corner of White Meadow Lake at Beach 3. Site 25 includes a parking area along North Lake Shore Drive, as well as a lakeside beach recreation area. This area is used for general recreation by the public, especially during the summer months. This location also contains a small drainage stream that receives runoff from the parking lot, North Lake Shore Drive, and the surrounding residential community stormwater system. The stream channel along the perimeter of the beach lot has exposed soil along the streambanks and lack of vegetated buffer. Refer to Photos 33 and 34 below for an example of the parking lot and stream bank areas respectively.

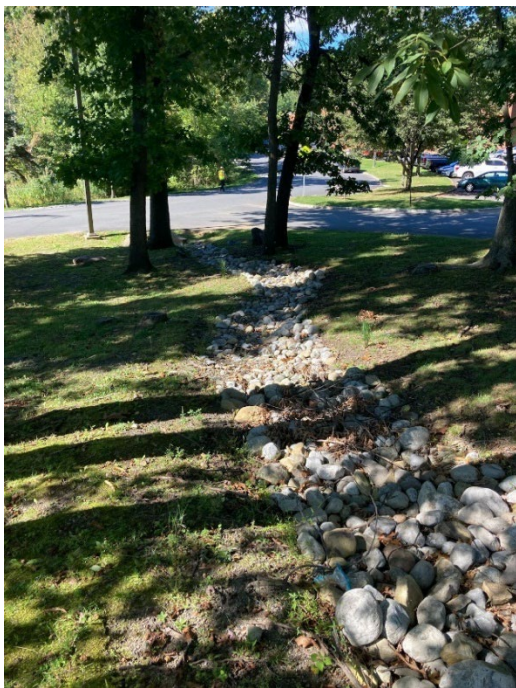
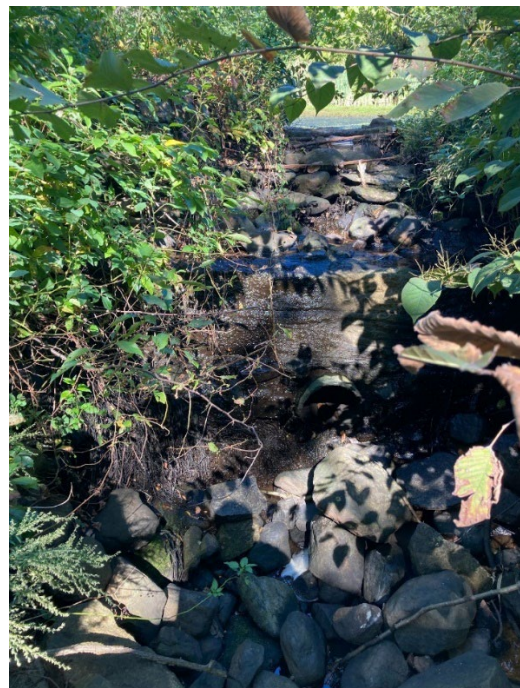
Photos 35-36: Current conditions of side rock-lined swale and Outlet structure of retention pond, showing outlet area blocked

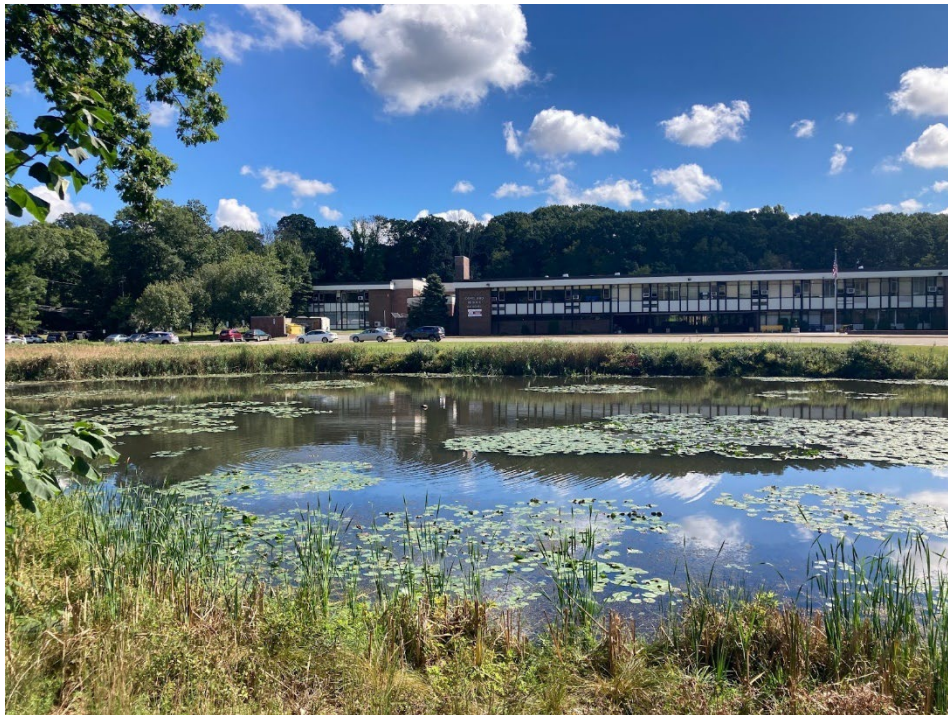
Photo 37: Pond at the front of the Copeland Middle School property

Copeland Middle School is located along Lake Shore Drive. This site contains an asphalt parking lot and pond at the front of the school property. The pond collects the stormwater runoff from the surrounding school property and streets, which are piped into the pond at various locations. The inlet and outlet pipes were obscured by vegetation during the site visit as well as vegetation growing in the open water.

Recommendation Site 27a - In-Lake Restoration: The first recommendation for this site is the implementation of “in-lake” management measures in the pond. This recommendation provides an opportunity to “treat” and/or “filter” the nutrient load that originates on the impervious property around the school and within the accumulated material within the pond. These recommendations can include the installation of biochar bags and floating wetland islands (FWIs). Both management techniques utilize natural processes to remove nutrients from the water column.

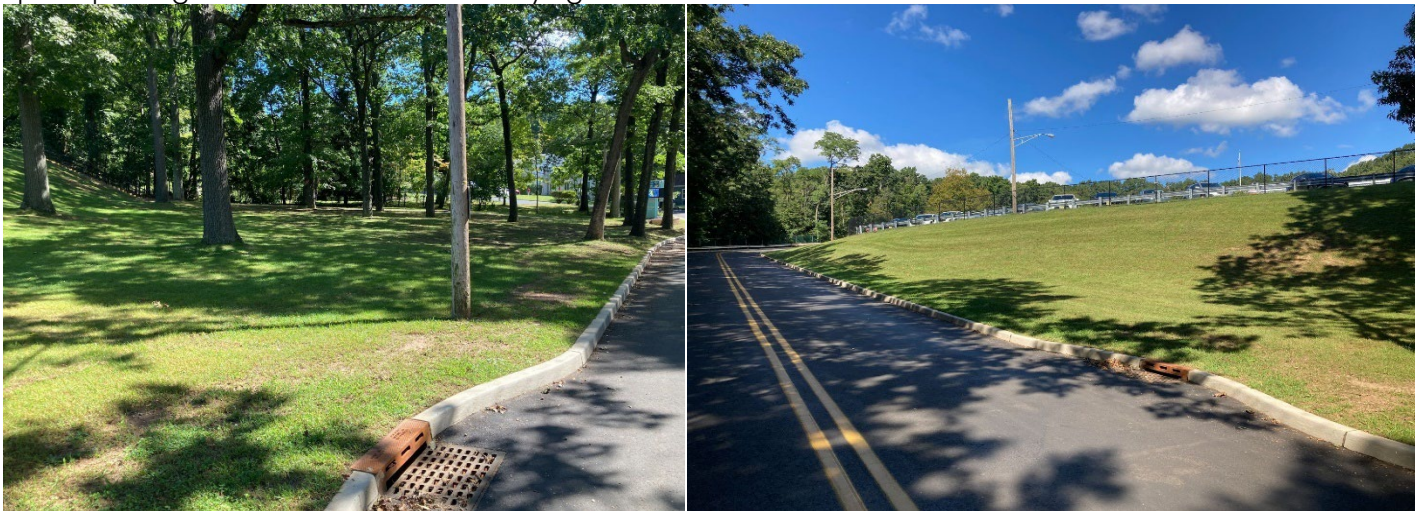
Stony Brook Elementary School is located off Stony Brook Road. The school complex includes an asphalt parking lot area, and an asphalt driveway connecting to Stony Brook Road. There were no observed stormwater management practices to retain or treat the runoff from these impervious surfaces. Thus, the stormwater runoff does not have any area to allow pollutants or nutrients to be filtered naturally or sequestered before entering Fox's pond, which degrades the water quality of the pond. The southern entrance driveway extending to Stony Brook Road contains stormwater piping responsible for draining the driveway area, as well as the impervious asphalt parking lot of the school all conveying it offsite.

Photos 38-39: Facing downstream and upstream at a potential stormwater BMP location at Stony Brook Elementary

Recommendation Site 28: As shown in Photos 38-39 above, the grassed area along the asphalt drive leading to Stony Brook Road would be an ideal location for a rain garden or other similar retention BMP. The inlet shown in the photographs above is connected to the outlet of stormwater drainage from the impervious parking lot area and driveway. A subsurface storage component would also be added to the rain garden to allow for stormwater storage and filtration within the practice itself. This rain garden would intercept stormwater from the impervious surfaces and filter pollutants from the impervious parking lot and driveway areas that drain to it. While this reduces pollution of Fox's Pond further downstream of the drainage line, it will also reduce stormwater runoff volume during major storm events, by storing some of the runoff volume within the soil of BMP. This BMP can also reduce flooding risk of the surrounding area caused by climate change.

Estimated Costs Site 28: The approximate cost for design, permitting, and implementation of this BMP recommendation is anticipated to be between \$150,000 and \$300,000.

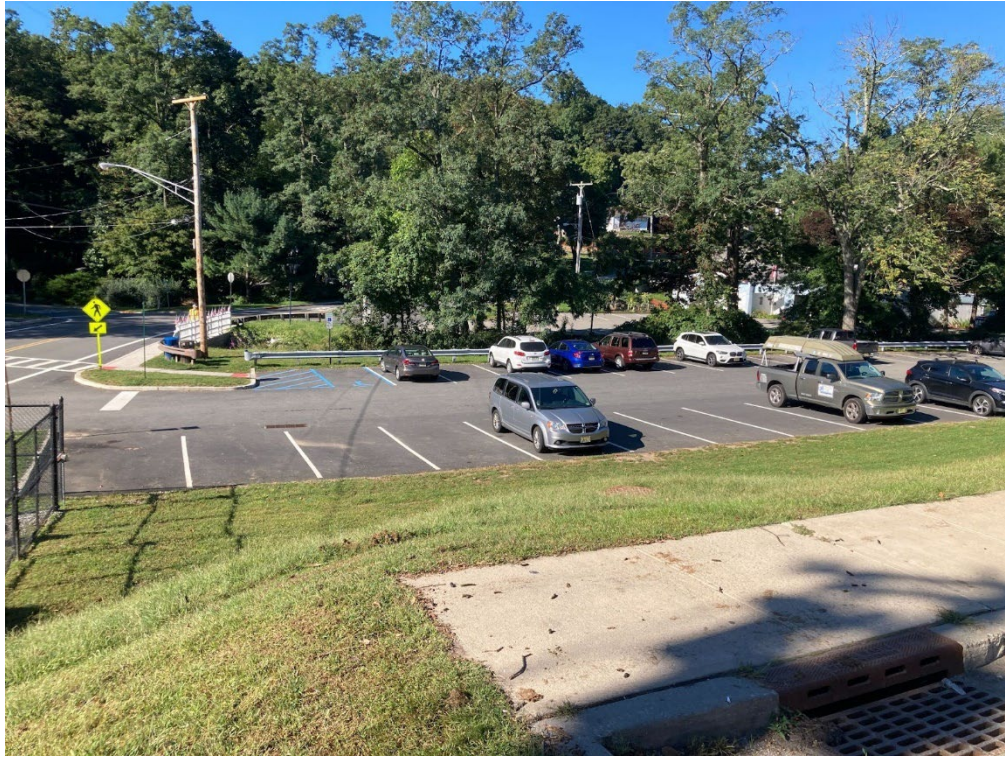
The parking lot area of a Rockaway Township Municipal Building at 19 Mt. Hope Road directly borders the northeastern side of Fox's Pond. This area is used by municipal workers and used for parking for access to the ponds walking paths. As shown in Photo 40 below, this site includes multiple impervious parking lots and streets within its drainage area that feed into its stormwater system. This stormwater system then directly discharges into Fox's Pond from the northeast.

Photo 40: Parking lot area of American Legion and Municipal area bordering Fox's Pond

Recommendation Site 29: As shown, the parking lot area entrance and various parking spots would be an ideal location for a porous paving system. Since the parking lot area contains a large amount of impervious asphalt, the porous paving system would be able to have a storage area underneath of the system, allowing for the storage of water and filtration of sediment from the water before it's discharged into the pond. This site provides the ability for parts of this system to be modular, installed in certain parking spaces as well. Additionally, the porous paving system would be able to intercept the existing stormwater pipe leaving the site under the entranceway, providing more treatment volume. This improves water quality by removing pollutants from the pond and allows for greater management of stormwater stemming from this location. This BMP system would initially delay excess runoff from entering the pond all at once during a storm event, which provides a way for this area to reduce flooding and manage stormwater runoff more effectively.

Estimated Costs Site 29: The approximate cost for design, permitting, and implementation of this BMP recommendation is anticipated to be between \$150,000 and \$500,000.

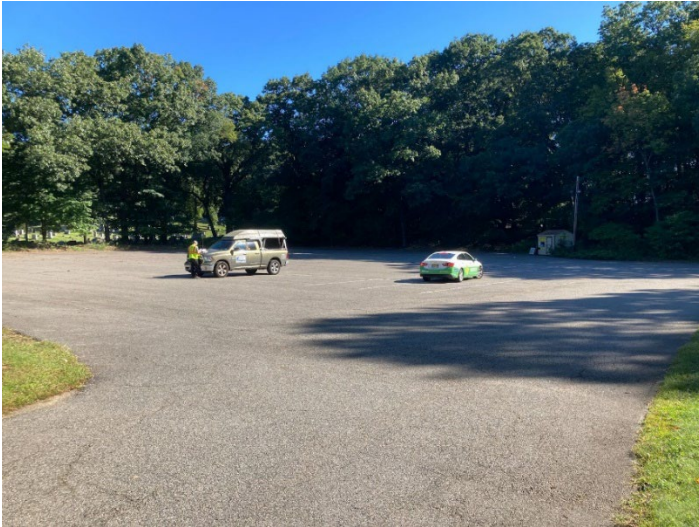
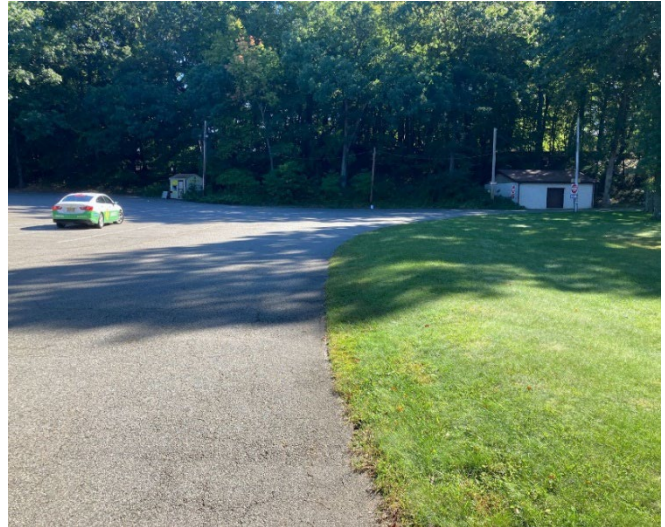
This site is a church parking lot that borders Fox's Pond to the East, off of Academy Street. This parking lot is used by the public to attend the church nearby, and to recreate at Fox's Pond across the street. This parking lot contains 33,000 square feet of impervious area that drains into Fox's Pond. Currently, the parking lot has no type of stormwater management system, with runoff from the parking lot draining along the surface to Academy Streets drainage system, which is piped directly into the pond. Because of this, there are no existing stormwater management features on this site.

Photos 41-42: South side of parking lot and entrance area, showing potential locations of BMPs.

Recommendation Site 30: The first recommendation would be the conversions of the existing lawn areas into bioretention systems. Due to the size of the parking lot, it is anticipated that multiple features may be necessary to treat the runoff. The main bioretention swale system would be bordering the southern part of the parking lot, extending the length of the grass strip and ending near the parking lot entrance; this area can be seen in Photos 41-50 above. The swale would drain to an outlet structure before connecting to the piped conveyance system on Academy Street and discharging into Fox's Pond. In addition to this bioretention practice, several parking spaces could be converted into smaller bioretention infiltration systems, spaced out through the parking lot. Since the parking lot is not full most of the time for church, converting some spaces to a bioretention practice would be an easy way to increase stormwater volume management and nutrient uptake at this location.

Estimated Costs Site 30: The approximate cost for design, permitting, and implementation of this BMP recommendation is anticipated to be between \$150,000 and \$300,000.

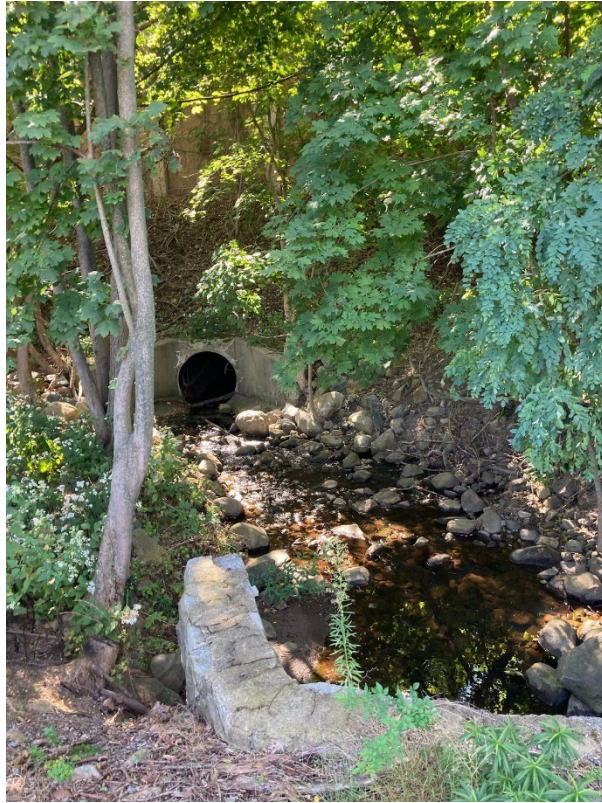
Photo 43: Outlet of street drainage system that drains to piping system under Route 80

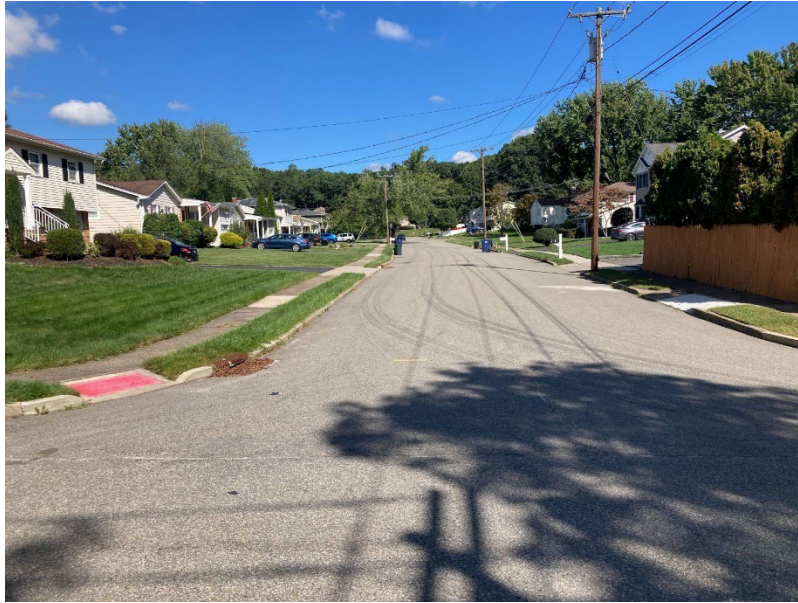
Photo 44: Example Location of ROW Bioswale on Barry Drive

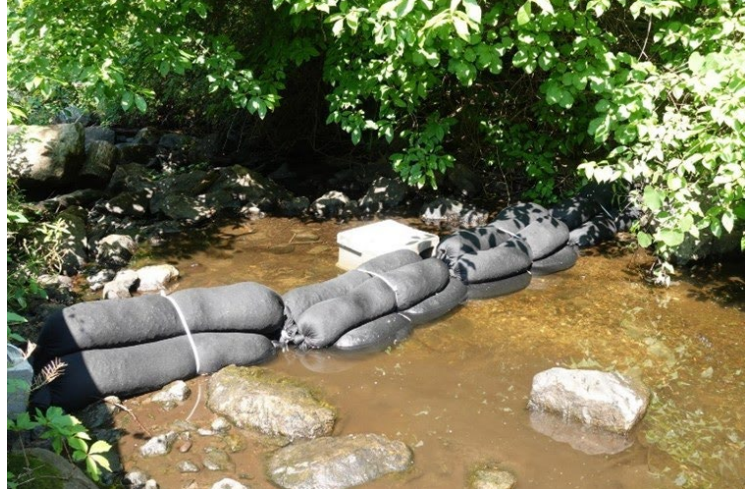
This material can be placed into flotation balls, sausages, or cages and tethered along a beach area swimming line, where an inlet enters the lake, or within streams themselves. Biochar set out in lakes and ponds, including stormwater ponds. It has been shown to remove dissolved phosphorus directly out of the nearshore waters, contributing toward limiting algal growth. Biochar set in streams will intercept these nutrients as the water passes through. Additionally, the relatively low cost of the Biochar and its re-use as a form of mulch make it a particularly attractive means of contributing toward the removal of in-lake phosphorus. Biochar strategically placed in lakes offers the opportunity to remove internally released phosphorus from the system, further complimenting the watershed management measures that reduces nutrient loads closer to the source. As such, biochar can remove legacy phosphorus and other nutrients that have built up in the sediments over time from the system completely, especially if the biochar is removed and replaced throughout the season.

Photo 45-46: Examples of biochar being used in ponds (left) and streams (right).
